Peculiarities of the static and dynamic failure mechanism of long-term exploited gas pipeline steel

Abstract

A section of the main gas pipeline “Kyiv—West of Ukraine-1” (KWU-1) was investigated after 40 years of operation under ground. The gas pipeline has a diameter of 1020 mm, wall thickness of 10 mm, and a rubber-bituminous insulation. The failure of insulation caused the formation of the corrosive damage on the external surface of pipes in the form of spots, pits, and cavities of different size and depth, due to the interaction between the pipe metal and the medium. Lack of insulation on the analyzed section of the main gas pipeline “KWU-1” from steel 17G1S according to TU 1-150-67 caused the formation of multiple corrosive damage on the external surface.¹² Table 1 shows the chemical compositions of the tested steel 17G1S.

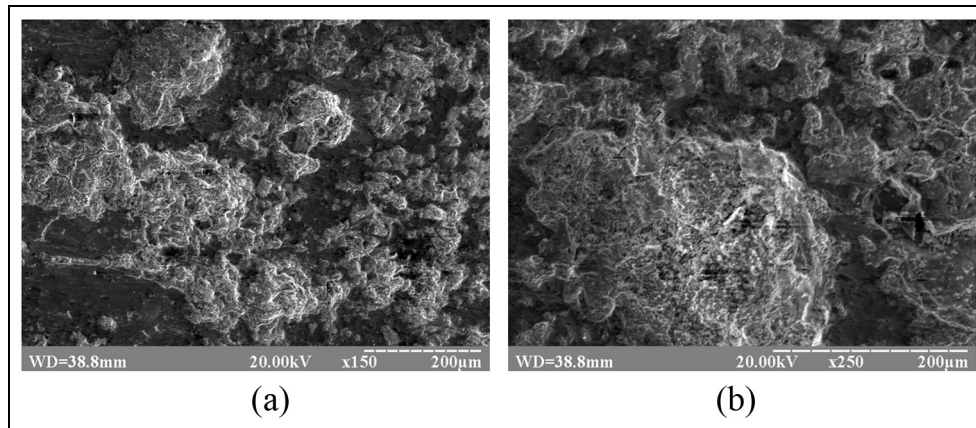
These two types of damages decrease the pipe thickness, which under certain circumstances may cause the formation of cracks and rupture of pipes. Based on the analysis of inspection of the pipeline corrosive status and the results of technical diagnostics, it is shown that the presence of corrosive pits (Figure 2) is the main reason for the hydrogenation of the pipe wall, which activates the processes of the structural damage of the material, thus decreasing its crack growth resistance.¹⁴

Figure 2. Corrosive pits found on the external surface of the gas pipeline after 40 years of operation (a) zoom factor is 150 and (b) zoom factor is 250.

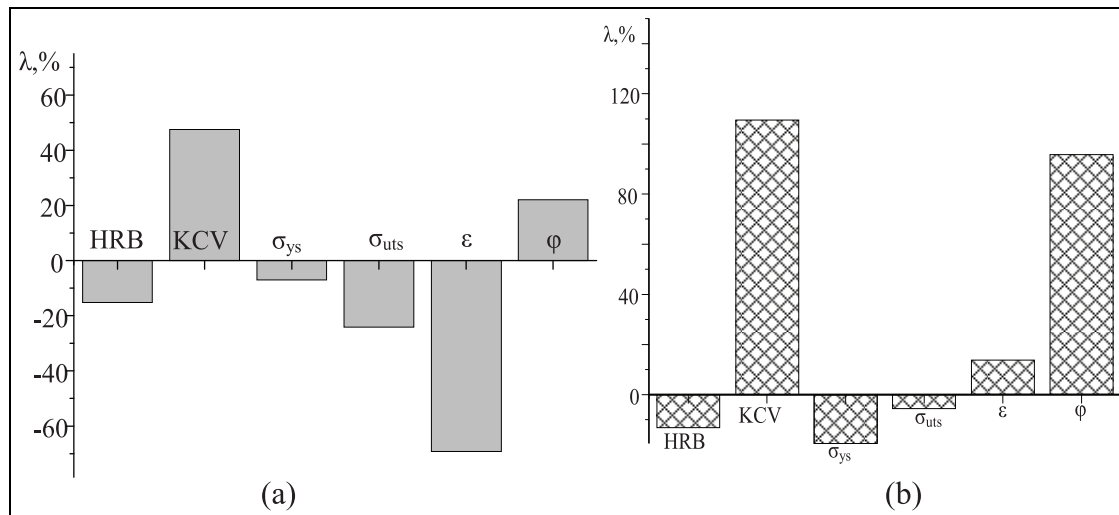
Figure 3. Degradation of the mechanical characteristics of steel 17GIS after 40 years of operation for the (a) longitudinal and (b) transverse directions of cutting.

A decrease in the impact fracture energy of the service-exposed material is caused by the formation of microcracks due to lamination and multiple damage of the material. An increase in the relative elongation of the main gas pipeline material (along the pipe) after operation from 23.5%–26.0% to 44.0% is found, as well as a decrease in the relative necking from 59% to 46%. The results obtained are generalized in Figure 3, and the value of degradation was determined, as an example,¹⁰ from the following formula

The generalized values (in relative units) of the pipe material degradation, which are determined based on the results of different test types and evaluation parameters, are presented in Figure 3.

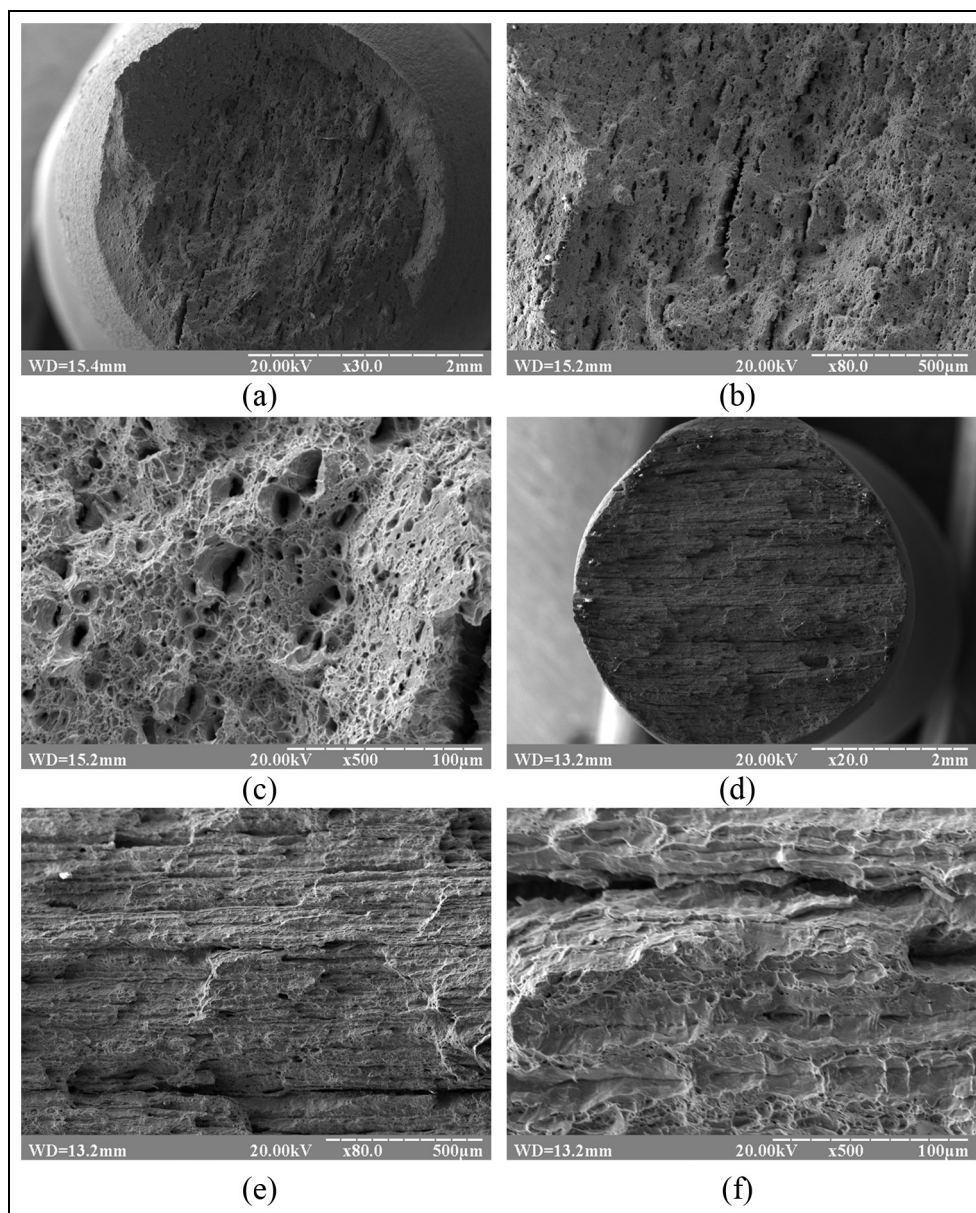
Longitudinal cutting. The specimen fracture surface testifies to the active plastic yielding of the material during deformation, during which the ductile separation with a multiple dimple formation took place (Figure 4(a)–(c)). The static deformation of the material results in a banded corrugated mesostructure of the surface layer. The plastic deformation bands are oriented in the force application direction.

causes the deformational and grain boundary hardening, as well as the increased sensitivity to strain localization, and proneness to the brittle spalling of the structural components.¹⁹ However, the “orderliness” of the banded structure, which is capable of impeding deformation processes on grain boundaries, causes quite a high strength of such a material, although a decreased plasticity, as evidenced by the neck shape (Figure 4(d)–(f)).

Figure 4. Fracture surface of specimens from the service-exposed steel I7GIS cut in the (a–c) longitudinal and (d–f) transverse directions after 40 years of operation.

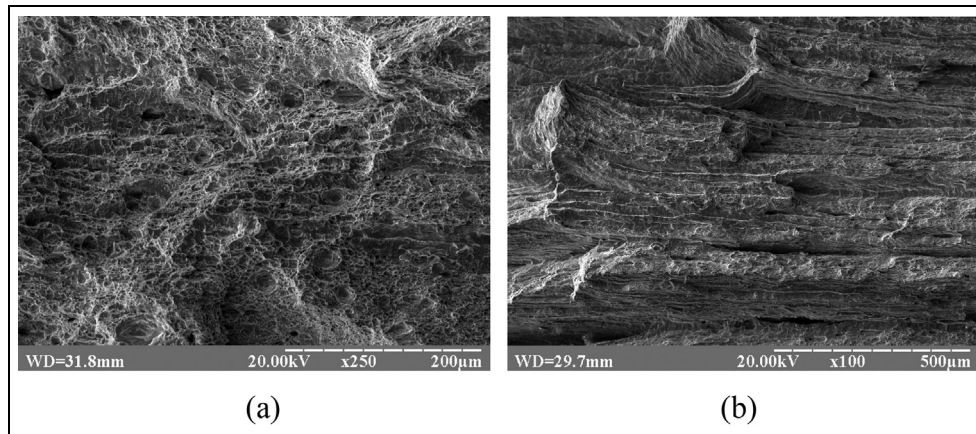
Figure 5. Fracture surfaces of specimens cut from the service-exposed steel 17G1S in the transverse direction (a) for a new pipe and (b) for a pipe after 40 years of operation.

It is known that the velocity of deformation has an effect on the “injection” of energy into the material, hardening of its matrix, and the accompanying processes of the material opening as a whole.²¹ The performed fractographic investigations of the specimens cut from the pipe in the transverse direction allow stating that the new pipe fails in the ductile manner by the dimple separation mechanism, which testifies to a high energy efficiency of the process (Figure 5).

Failure of the *service-exposed pipe* takes place with the formation of dissipative structures in the form of the voluminously connected localized bands of “channels.” Special attention should be paid to the geometrical distortions of channels detected on the surface, in the form of extractions with individual transverse laminations. This allows concluding that dissipative structures have quite a high level of structural and mechanical damage, which determines the non-uniformity of their dynamic failure, which is higher than static loading.
