Design errors and performance defects as causes of the risk for a collapse of the ceiling of the concert hall

Abstract. The issue presented concerns the proper assessment of a ceiling underneath a modernised concert hall in a historic building as a case study. The reason for a reconstruction was to replace a wood block floor with stone slab floor made of marble. Shortly after the construction works, cracks which appeared, made the floor unsuitable for further use. In order to determine the cause of the damage, a detailed analysis of a state of the construction was performed within the technical diagnostics. The first element that was inspected was the way the cracks were distributed. This layout was typical for overloading of ceiling. It was assumed that the thickness of the concrete overlay of the Ackerman floor was 9 cm. In order to verify the actual layout of the floor layers, five different opencast works were taken from the top level of the floor cavity blocks. The actual layout of the uncovered parts differed from both the assumptions that were made and the new design. The arrangement of the floor layers that differed from the design documents, caused the overloading of the

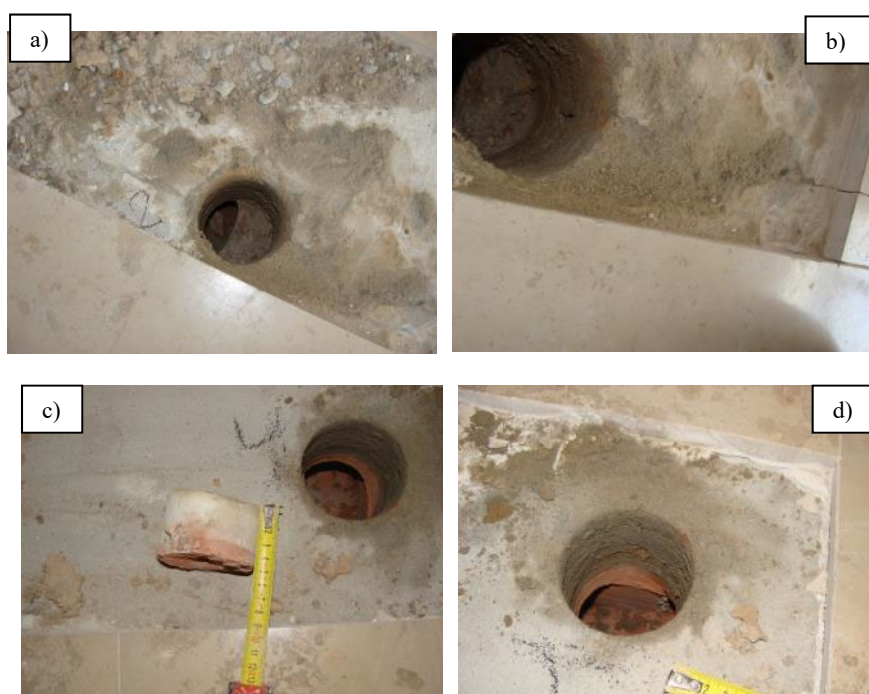
Figure 1. Examples of opencast works from floor layers: a, b) no. 2, c, d) no. 4

Basing on the opencast works it was established that assumptions of the statistical formulas attached to the design documentation of the building redevelopment were incorrect. The thickness of the Ackerman floor concrete overlay is about 3 cm (see Figure 1c) while in the design calculations (Studio AZR, 2007) and technical expertise preceding the renovation (Studio AZR, 1998), a thickness of 9 cm was assumed. That caused a significant increase of the value of the lever arm of internal forces and thereby the load bearing capacity of the floor was overstated. The lever arm of internal forces for bending assumed under design calculations is 23.0 cm and the actual one – calculated for the analyzed opencast works is 18.5 cm which means a reduction of the lever arm by over 24%. Additionally, the floor layers that had been made are not consistent with the design documentation. The design specification (Studio AZR, 2007) assumed 7 cm of stabilised sand with a characteristic load of 1.33 kN/m² when in reality there is an average of 6.5 cm of concrete screed and 1.0 cm of adhesive which amounts to a characteristic load of 1.74 kN/m².

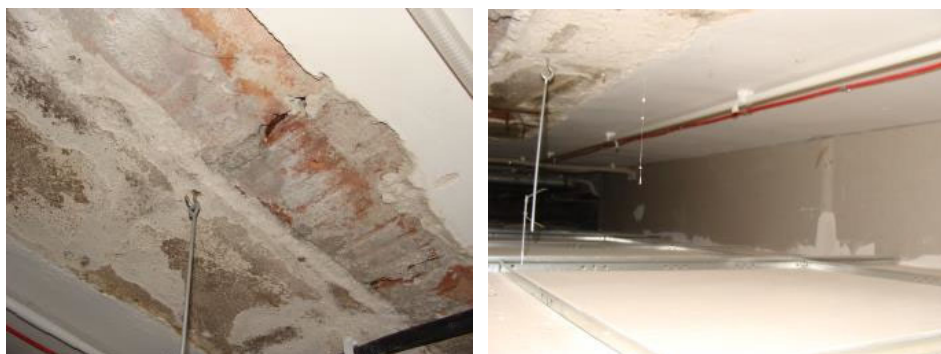
Figure 2. Views of the construction of Ackerman floor from the bottom

Looking at the bottom of the construction there were no signs of damage on the supporting structure. A ferro-magnetic device was used to measure the thickness of the cover of reinforcing bars which is 2.0 cm and the diameter of the reinforcing bar of the floor rib was 10 mm.

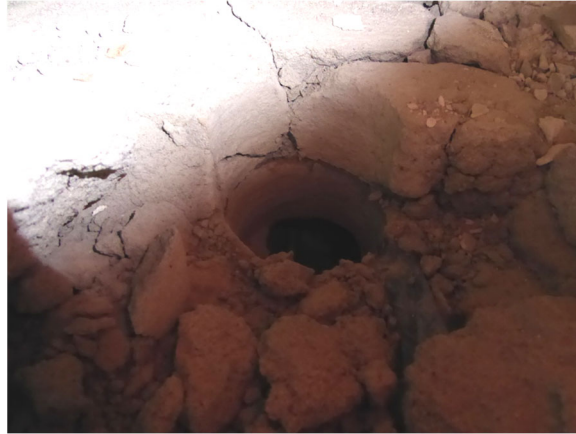
Basing on the floor opencast works, the computational value of the own weight load equalled to 8.67 kN/m² was determined in relation to the significantly lower (1.47 kN/m² difference) value equalled to 7.20 kN/m² that was incorrectly estimated by the designer. The process of reparation work carried on the floor was being monitored to make sure it was performed according to the project recommendations. The assumptions that were made during the expert evaluation of the discrepancies of the actual layout of the floor compared to the design documentation were confirmed as shown in Figure 3.

Figure 3. View of floor layers during demolition works

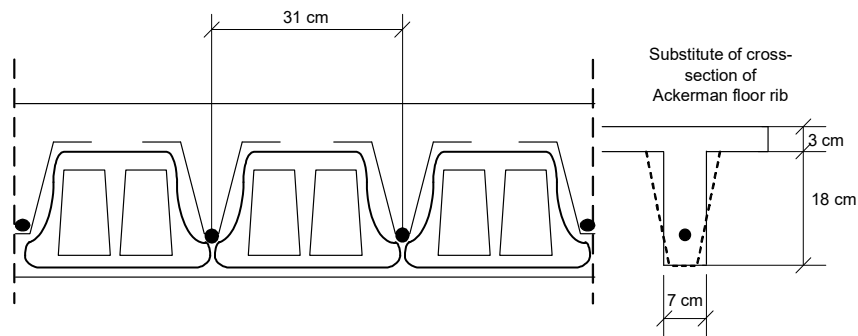
Figure 4. Adoption of cross-section of Ackerman floor rib

resulting in: $M_{Rd} = 2.77 \text{ kNm}$.
