Design analysis of strengthening a damaged supporting structure in a swimming pool building

Leopold Kruszka¹, Ryszard Chmielewski²

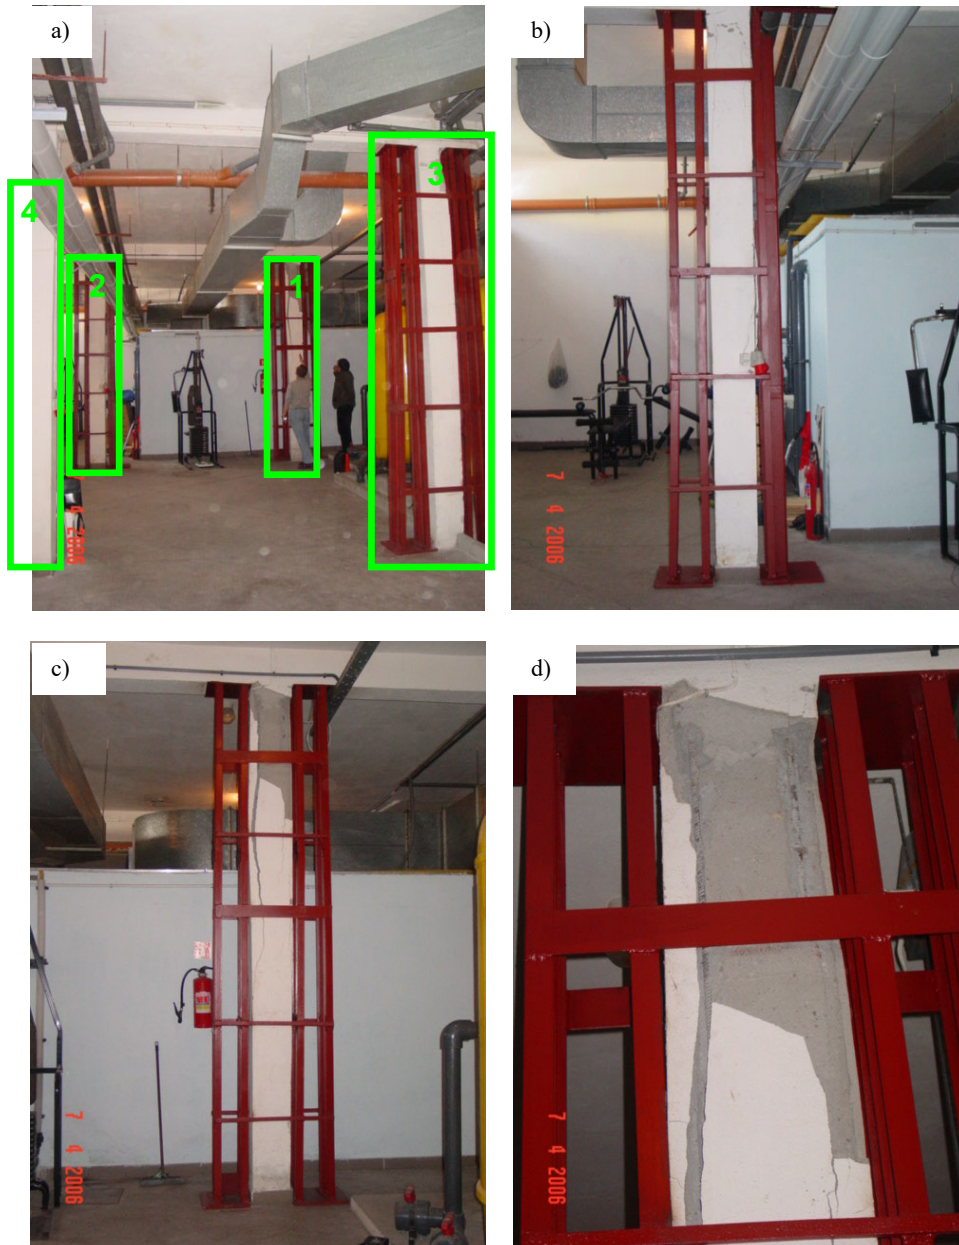
During on-site inspection that involved visual inspection of all the elements of the construction of the load-bearing structure it was found to be in a good technical condition, apart from the damaged supporting beams in the basement of the building – see Figure 3. The pillars were secured with a temporary steel supporting construction that was ordered by the building manager.

The technical condition of the damaged reinforced pillars in the swimming pool basement was described as the risk of the structural collapse. During the on-site inspection, numerous cracks were observed as well as the occurrence of deformations in the form of buckling. Three columns were been damaged in the basement – shortly (about a week) after the appearance of vertical cracks on one of the first pillar (Figure 3a), column no 1), the next two were been damaged (Figure 3a), columns no 2 and no 3). After the first pillar lost its load bearing capacity, the weight was transferred onto two neighbouring pillars that got overloaded as a result. The building manager immediately ordered construction works that involved assembling a temporary steel supporting structure that prevented a building collapse.

Figure 3. Overall views of the damaged reinforced concrete pillars in the basement. Damaged pillars are marked with numbers 1, 2, 3

The assessment of the concrete grade in the damaged pillars was conducted with a use of the Schmidt hammer type *N* following the ITB Technical Recommendation no 210. The assessment was carried on side surfaces of all the pillars in the sub-basin basement (position 5.4 in the design documentation). It was concluded that all the pillars were made of the same class concrete with a good material uniformity ($v_R = 11\%$). The average number of hammer reflections was $L = 22$. Due to the lack of possibility to drill opencast works on the pillars, it was not possible to verify the hypothetical curve for the material of the columns. Concrete class is determined by the strength of the mortar in a form

The strength was estimated at 10.6 MPa. The average concrete strength in the damaged pillars was concluded as corresponding with class B10 (C8/10 according to PN-EN 206-1:2002 (Polski Komitet Normalizacyjny, 2002)). This concrete did not meet the standard requirements of construction material for use in reinforced concrete constructions. The calculation tests of the strength of the pillars, taking into account the incorrect class of the concrete material, were performed. The total design load per the damaged pillar was estimated as 450.86 kN.

The next step was to design a reinforcement for the above supporting structure. This new structure was designed in a form of four-arm equal-angled cross-sections. Due to constructional damage, an additional safety factor was added in order to increase the total load exerted on a single pillar by 50%. This approach enables the redistribution of loads within the building structure that occurred as a result of the damage.

The new construction of the reinforced concrete pillars was designed as a four-arm equal-angled cross-sections of L 80×80×10 mm made of 18G2A steel where $f_{yd} = 295 \text{ MPa}$. The load per pillar is equal to $Q = 450.86 \text{ kN}$, the additional safety factor (adopted due to the damage) is equal to $\gamma_{dod} = 1.5$, therefore the total calculated load imposed per pillar is $Q(r) = 676.29 \text{ kN}$.

In the case of the damaged load-bearing pillars of the swimming pool building it was recommended to do the following steps:

- preparatory work (gathering construction materials, equipment and devices),
- moving the support structure 0.5 m away from each side of the damaged columns,

- taking off damaged wall plasters and cracked concrete from the damaged pillars,
- making holes in the basement floor to the upper surface of footings and removal of the plaster of the ceiling substrings in order to directly base the steel beams, the minimum dimensions of the holes in the flooring are 60×60 cm,

- hacking off the coating of the reinforcement bars at the top and bottom part of the reinforced concrete columns for plates at the middle and base of the column,

- the assembly of steel elements for reinforcing the concrete pillars in previously prepared places,
- filling of the spaces between the steel elements of the reinforcement of the construction and the damaged reinforced concrete ceiling using non-shrinking repair cement mortar,

- corrosion protection of the built-in steel elements,
- plastering of the pillars – plaster on the Rabitz steel mesh,
- filling in the floor around the reinforced pillars.

The construction work should be carried out sequentially for each pillar. The removal of the existing steel supporting the structures can only be done after all four damaged pillars are reinforced.

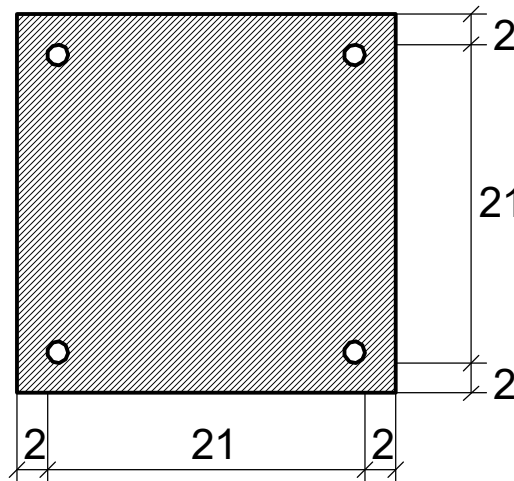
Calculation tests of the strength of the pillars taking into account the incorrect class of the concrete material were performed. The total design load per a damaged pillar was estimated as 450.86 kN. According to Figure 4 the following geometrical and material data for a damaged reinforced concrete pillar were accepted:

Figure 4. Reinforced concrete pillar cross-section. Dimensions in cm

Taking into account the actual concrete class C8/10 that was found in the damaged pillars as $f_{cd} = 5.2 \text{ MPa}$, then beam resistance is: $N_{RD} = 404.33 \text{ kN}$, and the ultimate limit state (ULS) condition is not met.
