Influence of technological and environmental factors on the behaviour of the reinforcement anchorage zone of prestressed concrete sleepers

Aidas Jokūbaitis*, Gediminas Marčiukaitis, Juozas Valivonis

Department of Reinforced Concrete and Masonry Structures, Vilnius Gediminas Technical University, Sauletekio ave 11, LT-10223 Vilnius, Lithuania

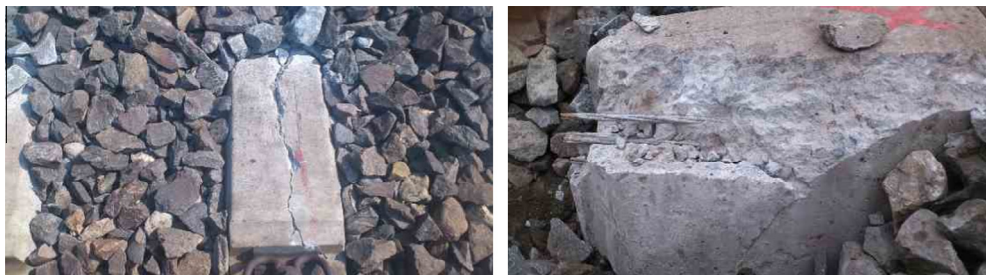
Fig. 1. End cracking of prestressed concrete sleepers.

Different sources [15,22,23] show that the most common part of the damage and deterioration of prestressed concrete sleepers used in the natural environment are observed at their ends (reinforcement anchorage zone) (Fig. 1). This can be caused by the impact of water and frost [21], alkaline corrosion [23], sulphate corrosion [10,12,22] or concrete micro-cracking [9].

Concrete samples of testing were taken from different ends of the used, similarly damaged prestressed concrete sleepers (Fig. 1). Analyses employing a scanning electron microscope (SEM) and Energy-dispersive X-ray spectroscopy (EDS) were carried out at the interface (C) between aggregate (A) and cement paste (Fig. 15a). As the picture of microstructure analysis shows, the biggest changes arising from different humidity (shrinkage) and

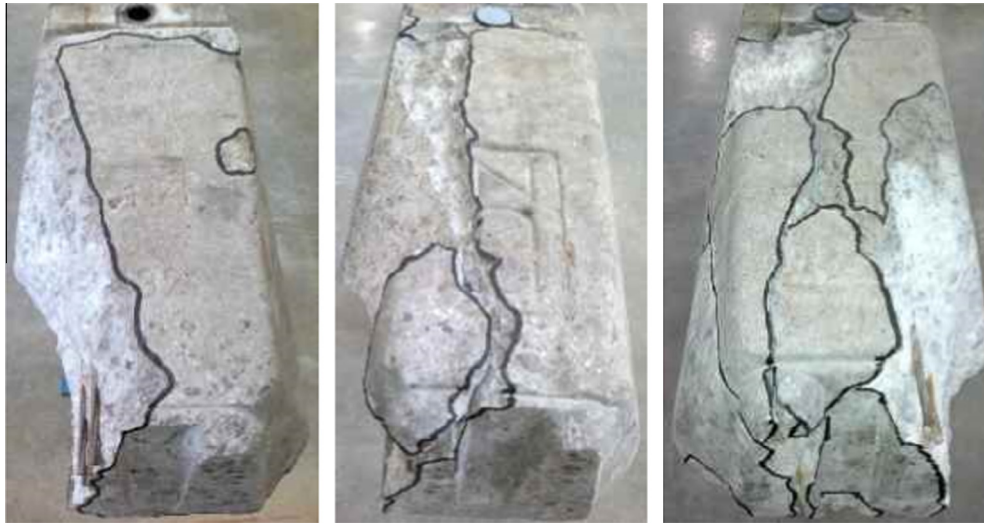
Fig. 8. Used prestressed concrete sleepers.

For investigation of the damaged ends of prestressed concrete sleepers, after reinforcement release, new (stored in warehouse) sleepers and those used for three years in the railroad track were used. Both used and new sleepers were produced at the same time in Lithuania and exploited in neighbouring countries (Fig. 8).

Investigation into the used sleepers has disclosed that their ends are damaged differently (Fig. 8). Some of them are slightly damaged and therefore cracking and spalling concrete at the other ends and the reinforcement anchorage zone is observed.

Ettringite usually forms on the concrete surface and is detected in concrete pores, cavities, cracks and micro-cracks around aggregates. Constructions, such as prestressed concrete sleepers, in service can be affected by a high temperature ($>60^\circ C$) during summer. Our researches and investigation done by other authors [12,14,22] have revealed that the deterioration of prestressed concrete sleepers used in railroad starts at their ends. The sleepers exposed to rainwater and variable effects of the sun are more damaged by internal sulphate attack than those constantly situated in the shadow and exposed to rainwater [10,43]. Our research also showed that more significant damages were detected at these ends of the sleepers situated on the south side and exposed to the sun, than ends of the sleepers situated on the northern side (Fig. 8).

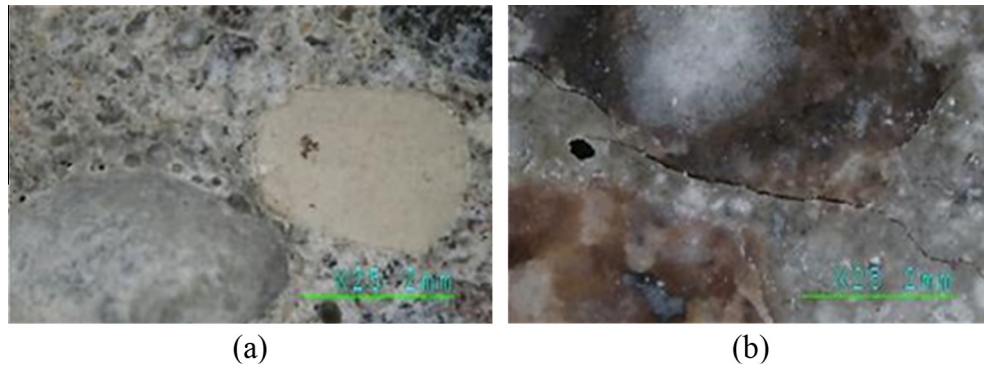
Fig. 10. Concrete structure of samples from sleepers: a – before soaking in alkali solution; b – after soaking for 46 days.

It has been determined that the structure of concrete samples cut from sleepers and soaked in alkali solution is damaged and surface cracks after 46 days (Fig. 10b). However, there were no cracks on the concrete surface of alkali unaffected samples (Fig. 10a). Concrete prisms were tested under bending and the tensile strength of concrete prisms soaked in the alkali solution was determined to decrease about 2 times.

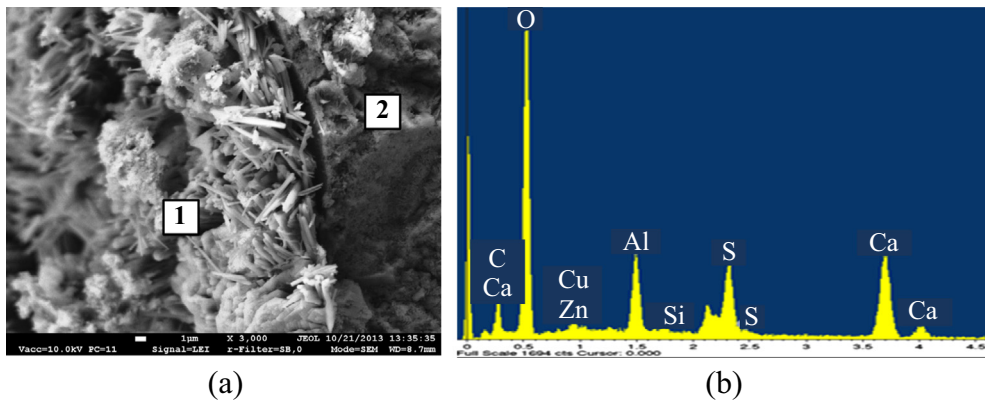
Fig. 17. Results of EDS analysis of specimen from the end of used sleeper at the interface between reinforcement and concrete: a – image of EDS analysis ($\times 3000$) (1 – interface between reinforcement and concrete; 2 – concrete), b – results of element concentration (%): O – 53.78; Al – 5.33; Si – 0.39; S – 7.94; Ca – 22.89; Cu – 2.33; C – 7.34.

needle-shaped crystals formed in the micro-cracks of concrete at the interface between reinforcement and concrete (Fig. 17) and about 50 mm from reinforcement (Fig. 16). An elemental composition of these crystals corresponds to ettringite ($3\text{CaO}\cdot\text{Al}_2\text{O}_3\cdot 3\text{CaSO}_4\cdot 32\text{H}_2\text{O}$).
