## Vibrations measurement of the funicular generated vibrations on Gediminas Hill North part slope

**Abstract.** An experimental measurements of the funicular generated vibrations provided after Gediminas Hill North part slope landslide, which occurred on 2016. The geology of Gediminas Hill made up strata of Quaternary system late Pleistocene glacial and glaciofluvial coarse and fine deposit. The purpose of this measurement was to determine, whether funicular generated vibrations during exploitation is the significant slope destabilizing factor. For vibration measurements in X, Y and Z directions were implemented equipment, developed by the authors. Measurements in 25 different points on the Gediminas Hill slope were performed during funicular movement up and down. Analysis of obtained results revealed, that the highest vibration level mainly localized at the top of funicular foundations, wave energy is not large, propagating waves greatly dampens in the soil and there is no effect for general slope stability and the funicular exploitation was not the main reason of the occurred landslide in 2016 Spring.

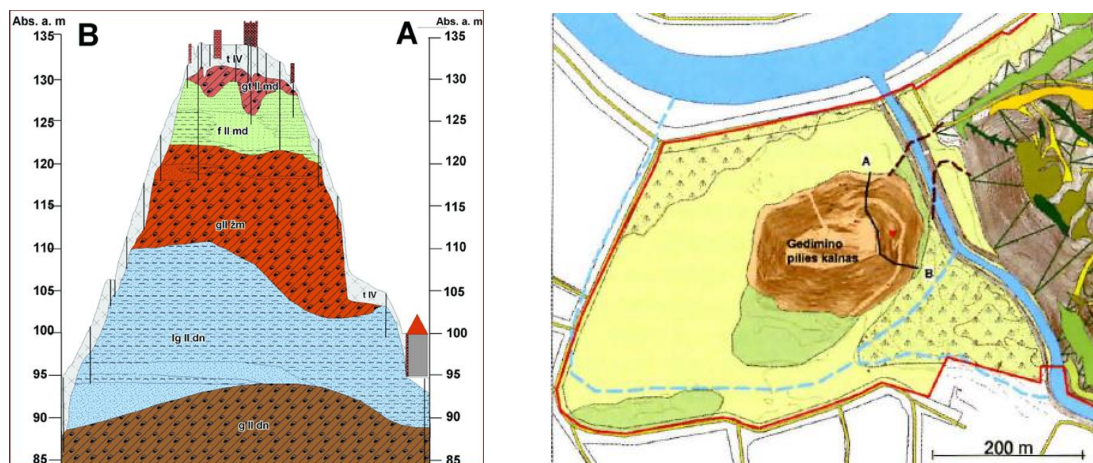
The geological information about Gediminas Hill has been obtained from borings and pits, and using a principle of analogy during which is comparing the data of others investigated hills in park. During the engineering geological investigations of Hill since 1955 up to now the total 431 borehole were bored. Only three deep boreholes were bored on a hilltop which reached 35–45 m of depth, the others were up to 4–10 m of depth (Drumsta *et al.* 2010). The main geological structure of erosional Gediminas Hill consist of stratified different ice ages glacial deposits such as morainic and fluvioglacial deposits, proglacial lake sediments. The basis of the Hill and bottom of Neris and Vilnelė rivers consist of the grey, very stiff morainic deposits (such as till and other mixtures of fine and coarse soils). These deposits occurred during the middle Pleistocene ice age – Dainava ice age (gII<sub>dn</sub>), about 400 thousands years ago. The bottom of the Hill made up from very dense greenish-grey proglacial lake sediments (such as fine and silty sand) (lgII<sub>dn</sub>). The thickness of the stratum 10–20 m. The middle part of Gediminas Hill is made up from brown stiff morainic deposits (such as till stratified with sand interlayers and lenses). These deposits was formed during the middle Pleistocene ice age – Žemaitija (Samogitia) ice age (gII<sub>žm</sub>), about 250–175 thousands years ago. The thickness of the stratum is 10–15 m. The upper part of the Hill consist of fluvioglacial deposits, which was deposited during the middle Pleistocene ice age – Medininkai ice age (fII<sub>md</sub>), about 175–130 thousands years ago. The thickness of the stratum is 6–8 m. The deposits of this stratum consist of dense fine sand with silty sand interlayers. The superface of fluvioglacial stratum is covered with terminal morainic deposits of middle Pleistocene Medininkai ice age (gtII<sub>md</sub>). The deposits consist of thin layers (from 0.5–1.0 to 3.0–5.0 m of thickness) of firm and stiff brown till, with interlayers and lenses of sand. The most upper part of the Hill made up of the Holocene age artificial deposits (tIV). The thickness of the layer is 4–5 m. The slopes of the Gediminas Hill is covered by deluvium and artificial deposits. The thickness of layer is very uneven, on the hillside from 0.0 to 1.0 m or little more, at bottom of the slope up to several meters (Fig. 1) (Gaigalas, 1983; Guobytė 2008).

Fig. 1. Geological cross-section of Gediminas Hill (on left hand) and position and direction of cross-section line (on right hand) (Guobytė 2008)

The hydrogeological conditions of Gediminas Hill mostly depends on the amount of precipitation (Coppola *et al.* 2006; Dibal *et al.* 2014; Osman, Barahbah 2006). The part of precipitation water seep through the artificial (tIV), morainic deposits (gtIIImd) and fluvioglacial sand (flImd) to the surface of Žemaitija (Samogitia) morainic deposits. Because the surface of this moraine is uneven and have the inclined hollow in centre, the groundwater discharged on the Hill east slope and forming the spring. Due to this phenomena in 2004 and 2008 (Čyžienė *et al.* 2012) there were two landslides in the Eastern part of Hill. Furthermore, the surface of stratum of Žemaitija morainic deposits has inclination to north direction (Fig. 1). Due to, the groundwater discharged on the North side of Hill, where landslide occurred in 2016.

Surface soil type of landslide and below it, can't be classified. It is mix of cohesionless and cohesive soil i.e. in one top layer can be found pure sand, in another – clay (see Fig. 1). Looking at overall picture of landslide soil, it is not homogenous cohesive soil. Considering this assumption the factor of safety ( $FS$ ) for an infinite slope with seepage can be expressed as follows (Bolton 1979):

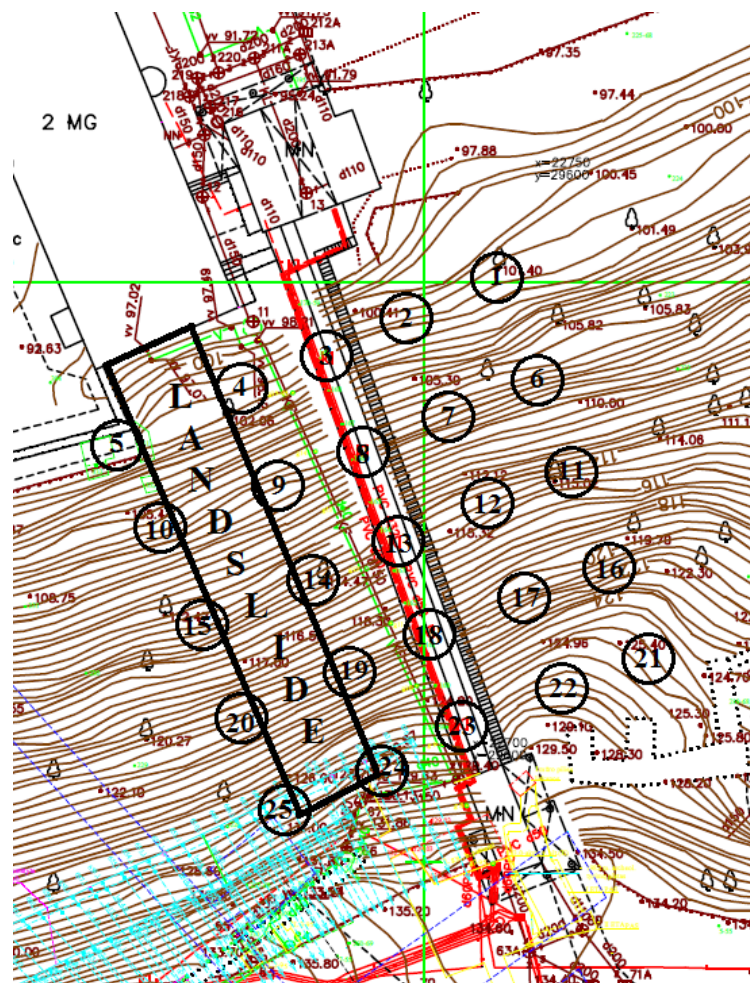
Funicular vibrations area determination was started after 15 02 2016 Gediminas Hill North part landslide. The occurred landslide was only in 10 m distance from funicular. Vibrations monitoring was realised with 25 vibrations measurement points (Fig. 2).

Fig. 2. Vibrations monitoring points and indication of landslide area

Distance between vibrations monitoring system indicators in horizontal plane was 10 m. At the vibrations monitoring area Gediminas Hill slope inclination varies from 35–40 to 60 degrees. Distance between horizontal vibrations monitoring system indicators rows was 11.80 m corresponding to funiculars pile foundations position (3; 8; 13; 18; 23 point in Fig. 2). In total, vibrations monitoring covered 1888 m<sup>2</sup> area, continuously recording soil surface vibrations when funicular was moving up and down. Surface vibrations in an elastic half-space are related to different waves types and traveling directions (see Fig. 3–4).

Worst case scenario of all 25 vibrations measurement points (see Fig. 2) was chosen for determination of critical acceleration. Obtained maximum accelerations amplitude (see Fig. 5) was in vibrations measurement point No. 23

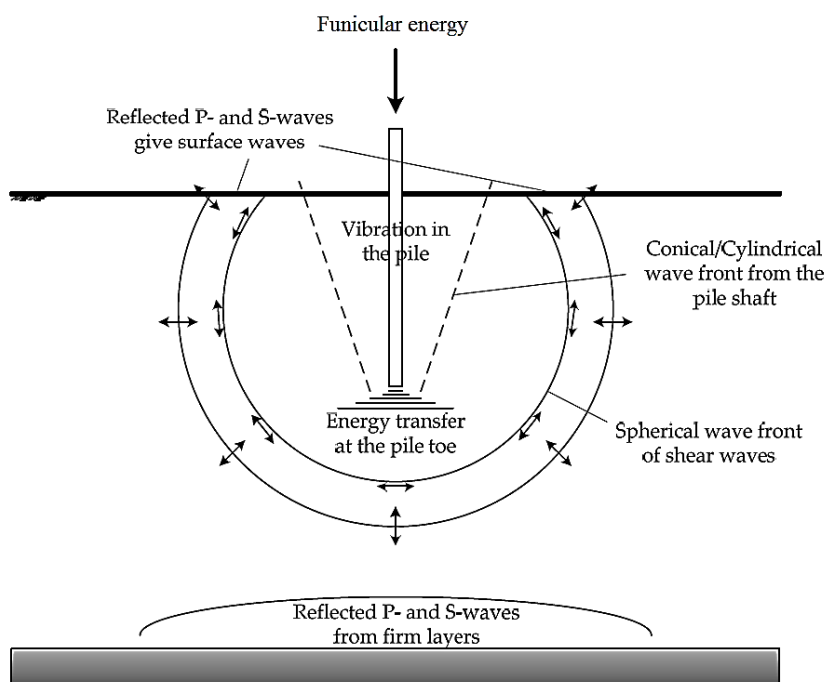
Fig. 3. Improved Deckner (2013) schematic representation of different wave types that can be generated from funicular

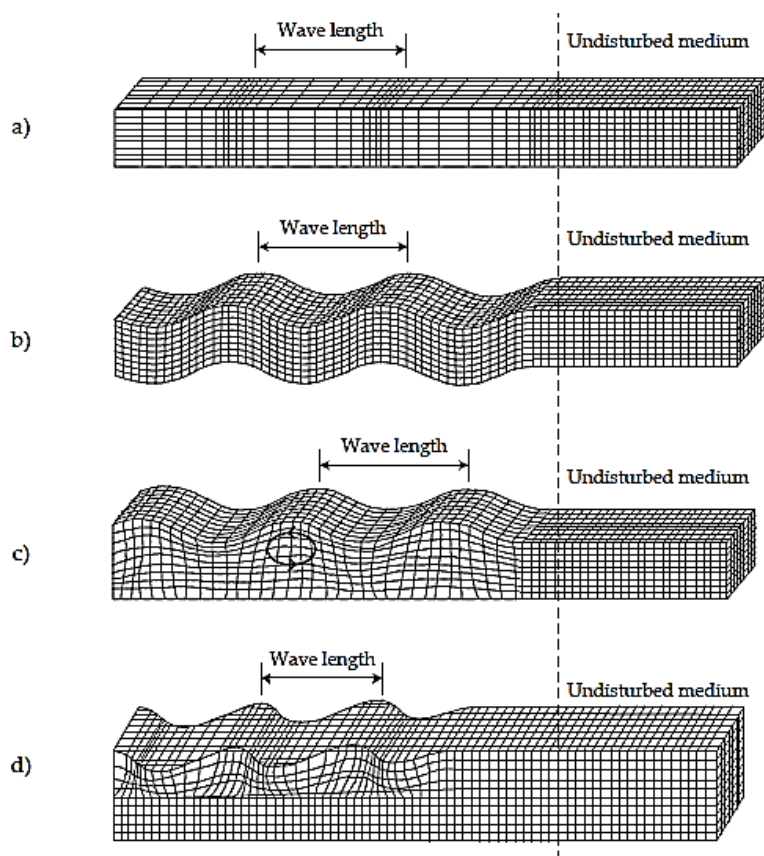
Fig. 4. Displacement characteristics of different wave types: a) P-wave, b) S-wave, c) R-wave and d) L-wave (see Deckner 2013)

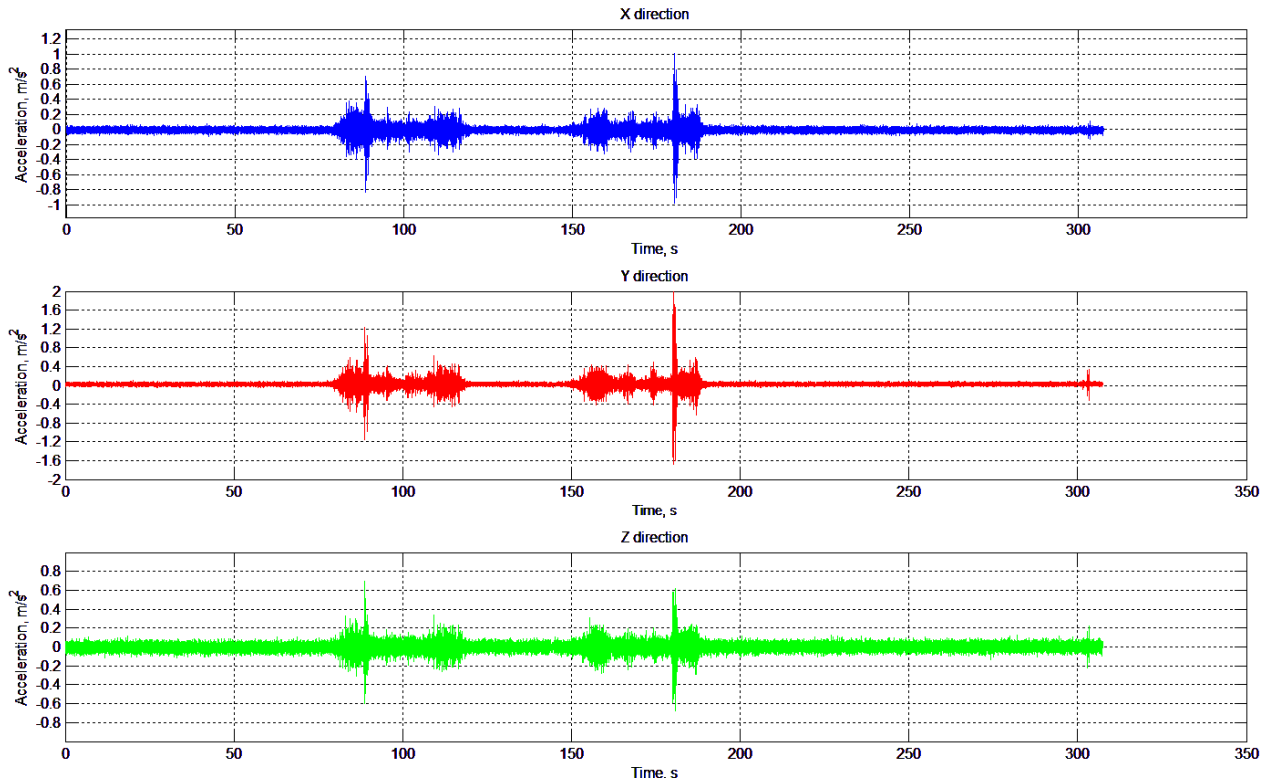
(see Fig. 2), where accelerations in X axis min/max -0.985/1.014; in Y axis min/max -1.686/1.995 and in Z axis min/max -0.679/0.691.

Fig. 5. Obtained maximum accelerations in vibrations monitoring area

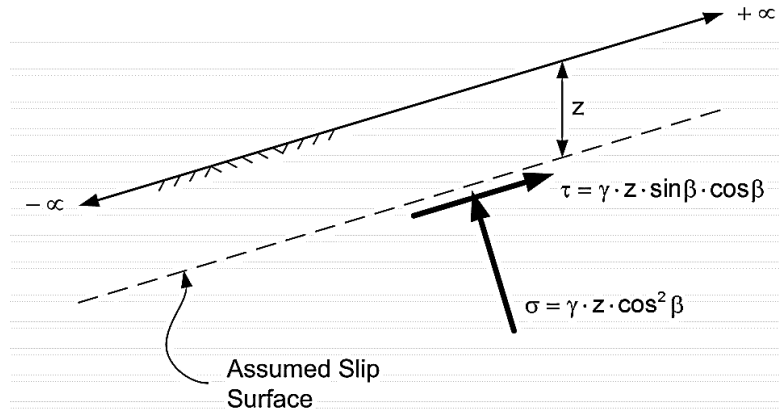
Care and attention must be given to below guidelines because importing graphics packages can often be problematic. Analysis of obtained results planned to be performed using static and dynamic slope stability. Static slope stability has to be performed in order to determine overall slope stability and to determine critical acceleration for dynamic slope stability. Static slope stability analysis was performed using infinite slope method. That kind of method was chosen because type of Gediminas Hill occurred landslide mechanism (Fig. 6).

Fig. 6. Infinite slope failure (CECW-EW 2003)

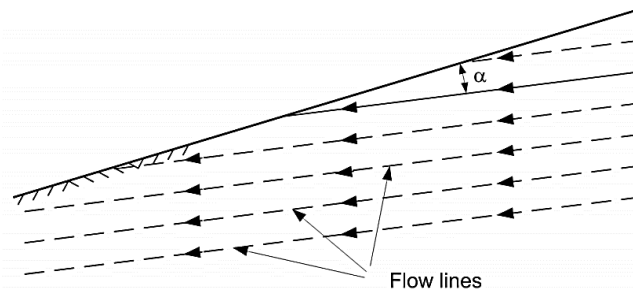
where:  $\gamma'$  – submerged ( $\gamma' = \gamma_{sat} - \gamma_w$ ) unit weight of soil (kN/m<sup>3</sup>);  $\gamma_{sat}$  – saturated unit weight of soil (kN/m<sup>3</sup>);  $\gamma_w$  – unit weight of water (kN/m<sup>3</sup>);  $\alpha_s$  – angle between the flow lines and the embankment face (degrees) (see Fig. 7);  $\beta$  – inclination of the slope measured from the horizontal plane (degrees);  $\varphi'$  – angle of internal friction expressed in terms of effective stresses (degrees).

Fig. 7. Infinite slope with parallel water flow lines (CECW-EW 2003)

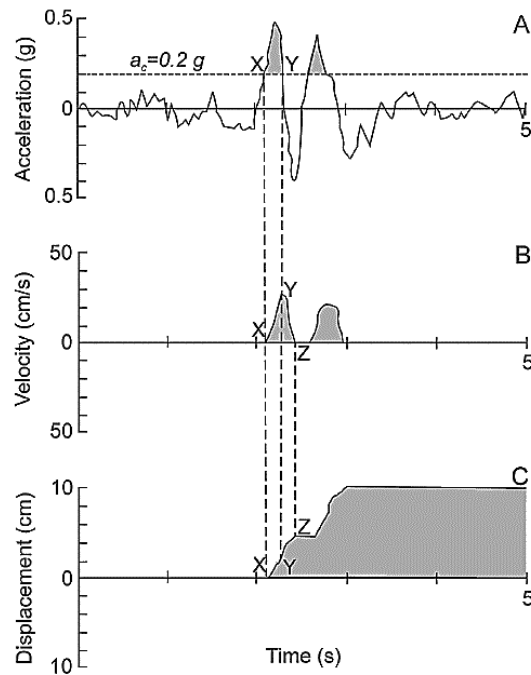
Newmark (1965) introduced a method to assess the performance of slopes during earthquakes that bridges the gap between overly simplistic pseudostatic analysis and overly complex stress-deformation analysis. Newmark’s method models a landslide as a rigid block that slides on an inclined plane; the block has a known yield or critical acceleration, the acceleration required to overcome basal resistance and initiate sliding. An earthquake strong-motion record of interest is selected (Fig. 8), and those parts of the record that exceed the critical acceleration are integrated to obtain the velocity–time history of the block; the velocity–time history is then integrated to obtain the cumulative displacement of the landslide block (Jibson 2011).

Fig. 8. Illustration of the Newmark integrations algorithm: A – earthquake acceleration-time history with critical acceleration (dashed line) of 0.2 g superimposed; B – velocity of the landslide versus time; C – displacement of landslide versus time; X, Y, and Z points are for reference between plots (Jibson 2011).
