18th International Conference on Rehabilitation and Reconstruction of Buildings 2016, CRRB  
2016

## Aar in Precast Concrete Wall Elements

This paper investigates defects (pop-outs) in precast concrete facade, caused by Alkali-aggregate reaction (AAR) on insulated wall elements, which were produced in Lithuania and shipped to Sweden. Links between climate data and AAR were found, samples from the site taken and studied with optical microscope. Information about concrete composition, aggregate granulometry and AAR risk discussed. Finally, possible AAR preventive measures for such production technique discussed and repair of the facade described.

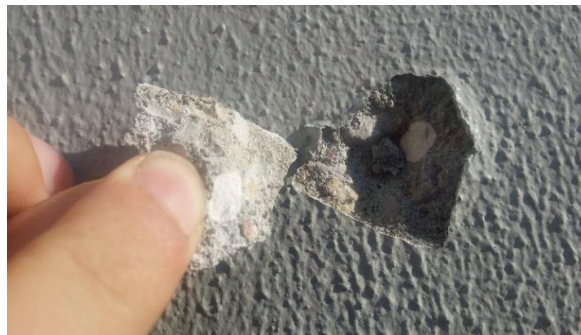
Tests have been conducted in order to determine causes of defects in wall elements (figures 3, 4) Wall elements for Helsingborg project were produced and assembled in mid- summer of 2011. AAR defects reported in the spring of 2013. Sizes of walls are around 7m by 3m and up to 100 pop- outs found on some of the elements. Defects are on all facades of the building, they do not show any connection with cardinal points. Cross section of elements is shown in figure 5.

Fig.3. Maximum size of scales- about 30mm

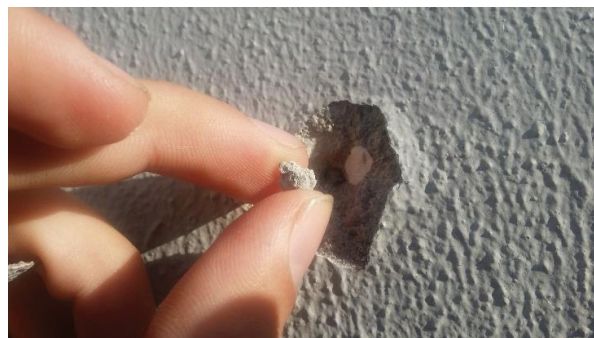
Fig.4. Maximum size of reacted aggregate- 4-5mm

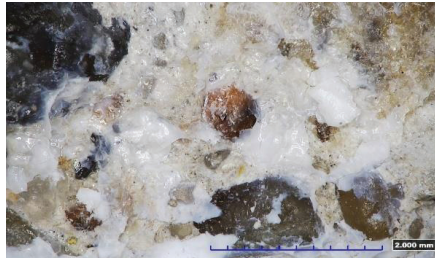
During examination, it has been determined that local defects appear in the external layer of insulated precast concrete walls due to reactive  $\text{SiO}_2$  particles in fine aggregate, that are located near the surface. Optical microscopy allowed to identify traces of reaction products- silica gel, which is around the aggregate (Figures 10 and 11).

Fig.10. Traces of silica gel found with optical microscope

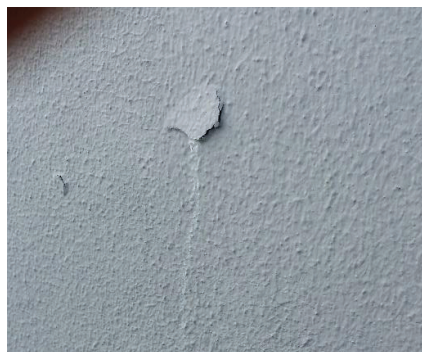
Reaction zone is very porous and consists of big amounts of glassy silica gel, which is a result of chemical reaction between alkaline compounds, found in cement and reactive siliceous aggregates. Semipermeable siliceous membrane forms around the aggregate which allows water molecules and sodium and potassium alkaline solution to travel only one direction- towards the reactive aggregate. In such a way, big internal forces are created around the aggregate, pushing out the scales of concrete. After the forces are released and channels to the surface opened, water washed out the reaction products from the reaction zone (Figure 12).

Fig.12. Reaction products leaching from the scales

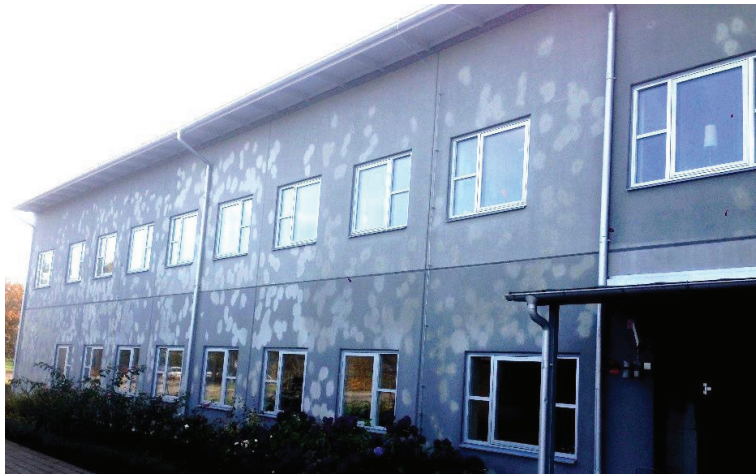
Fig.13. Facade in Helsingborg during repair

AAR in precast concrete walls causes esthetical damage of facades, which is hard to repair due to the fact, that AAR is ongoing process and new defects can appear in the future. To slow down the speed of AAR-reaction and the phenomena of AAR, Hydrophobic agent can be applied in order to stop the moisture or water infiltration into the concrete pores/capillaries. In case of Helsingborg, cylinders in the places of defects were drilled and covered with non-shrinking Portland cement based concrete repair mix (Figure 13). After that, whole facade was repainted.

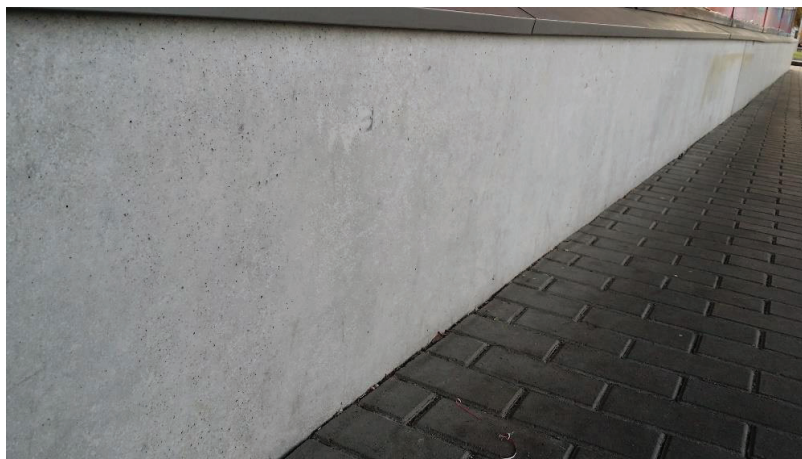
During this research, 10 projects in Kaunas, manufactured during 2010-2012 at the same factory were visited with a goal to find signs of AAR. Even though concrete composition and aggregates were same as for Helsingborg project and most of visited buildings were super markets with ground elements near parking areas with higher risk of moisture, no signs of AAR were found (Figure 14).

Fig.14. No AAR found on socle elements in Kaunas
