Energetic Refurbishment of Historic Brick Buildings: Problems and Opportunities

Jurgis Zagorskas¹, Gražvydas Mykolas Paliulis², Marija Burinskienė³, Jūratė Venckauskaitė⁴, ¹⁻⁴*Vilnius Gediminas Technical University*, Torben Valdbjørn Rasmussen⁵, ⁵*Danish Building Research Institute, Aalborg University*

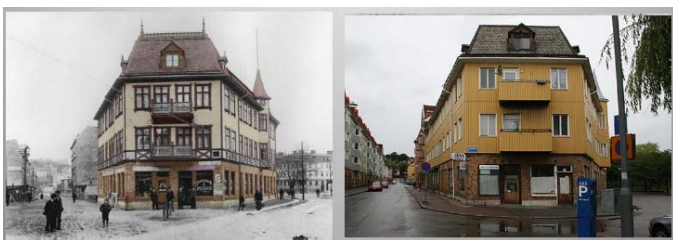
Fig. 3. Example of refurbished building when energy performance was increased to meet modern standards, but the authentic look of the building was destroyed.

In the refurbishment process of historic buildings there needs to be a compromise between payback period, comfort level, and preservation of historic authenticity of the building. Increasing energetic performance of the building usually means that some valuable details of the building are lost or replaced by imitations. Fig. 3 shows a typical example when the building was insulated from the outside to increase u-value of outer walls, and after such refurbishment lost attractiveness and historic character.

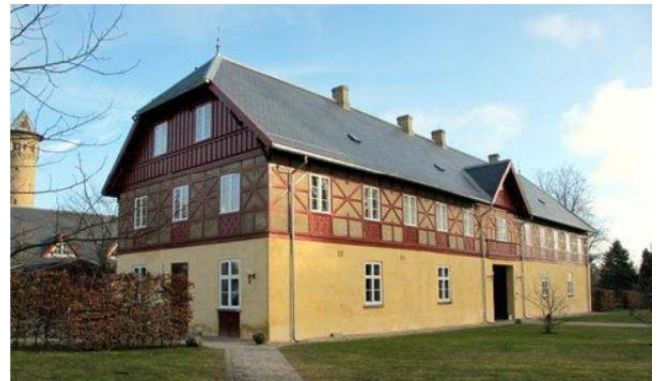
Fig. 5. Kavalergården building after refurbishment

One of the typical examples is the Kavalergården building refurbishment in the outskirts of Copenhagen, Denmark (Fig. 5). The building was constructed in 1877 as part of an architectural ensemble of the Bernstorff palace. Before recent reconstruction, the building had deteriorated and it was decided to renovate it and increase energy performance. Refurbishment works included change of roof tiling, roof insulation, use of modern lanterns, change of regular window glass to reflective glass, change of doors, and installation of an effective modern lighting system. According to theoretical calculations, the energy savings on heating should decrease by 22 %. The measurements done after one year of functioning of the refurbished building indicated that the energy savings were

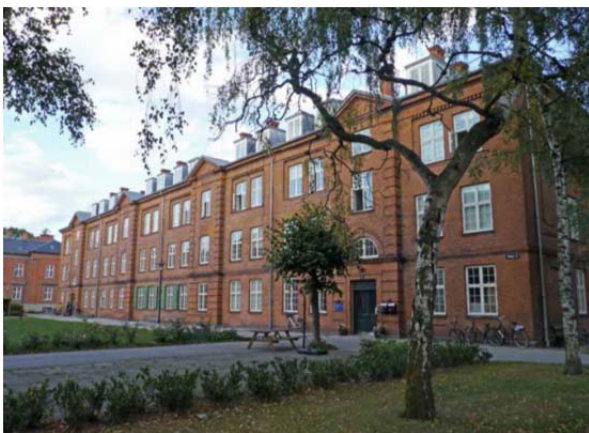
Fig. 8. Elmehuset building after refurbishment

Another example – energetic refurbishment of multi-flat house Emehuset in Copenhagen, Denmark (Fig. 6), when the main measure taken was insulation of outer walls and roof. The exterior of this former poorhouse in solid masonry, with

In the year 2009 it was concluded that the building needs renovation, the windows and plumbing needed replacement. Facades were considered valuable features of the building and it was prohibited to make outside insulation. The outlook of the building had to be kept the same to have the same style and appearance as the surrounding buildings. The building had G class of energy performance. The combined measures of roof insulation, changing of outside doors and windows, reinstallation of electricity cables, lighting system and plumbing, change of convectors and ventilation system, and inside insulation of outside walls in stairwells were applied. After refurbishment the building was certified for C class in energy performance.

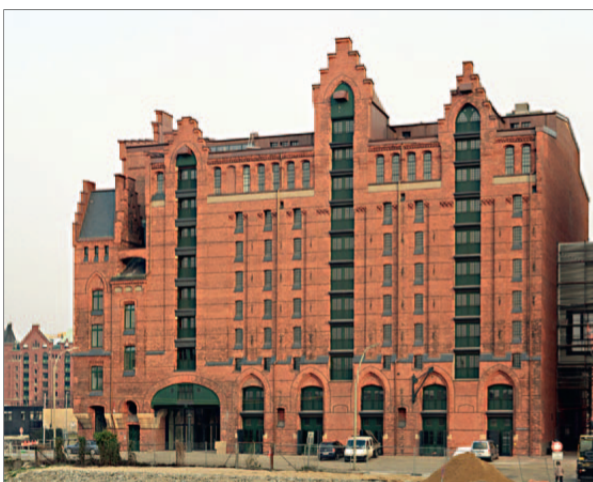
Fig. 9. Historic building reconstruction in Hamburg

Very often wall insulation is not applied in historic building energy refurbishment. Storehouse refurbishment in Hamburg (Fig. 9) to suit the needs of a museum and exhibition center provides such an example. The energy in this project is saved mainly by an innovative HVAC system. The building had masonry walls 80cm thick and more. In the basement there was enough floor space to install a modern HVAC system. Floor heating was installed in the ground floor. Modern windows with controlled air leakage allow air to come inside the building and as the air is heated it gradually rises to the roof through the central hall and comes out through the ventilation openings. There are infrared heaters on the ceilings on every floor working only when the room is in use. The cost of this reconstruction was 28 mill. €.
