Carbonation of Alumina Cement-bonded Conventional Refractory Castable in Fireplace

Ina PUNDIENĖ*, Stasys GOBERIS, Valentin ANTONOVIČ,
Rimvydas STONYS, Algimantas ŠPOKAUSKAS

Vilnius Gediminas Technical University of Thermal Insulation, Linkmenų 28, LT-08217 Vilnius, Lithuania

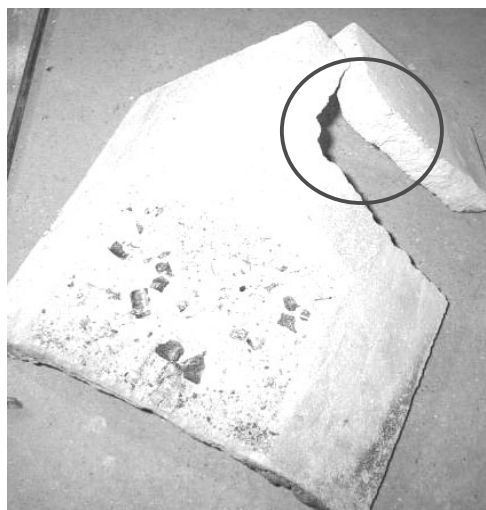
Fig. 1. Examples of castable products destruction in boiler (size $(40 \times 20 \times 5) \text{ cm}$ and $(60 \times 40 \times 10) \text{ cm}$)

Practical observation showed, that alumina cement-bonded castable blocks of boilers that are heated by biofuel disintegrate and fracture (Fig. 1).

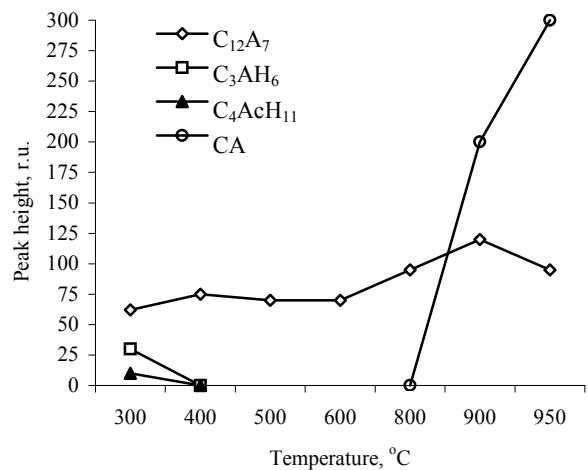
Fig. 3. Changes of peak height of minerals (C_3AH_6 ($d = 0.229$ nm), $C_{12}A_7$ ($d = 0.220$ nm), C_4AcH_{11} ($d = 0.76$ nm) and CA ($d = 0.297$ nm)) representative peak after firing

After firing at the interval of 300 °C – 950 °C temperatures minerals $C_{12}A_7$ and CA were determined, and C_3AH_6 was determined only after firing at 300 °C temperature because it disintegrates at the temperature of 360 °C (Fig. 3). The results might be explained by dehydration scheme of cement mineral hydrates [10]:

Amount of $C_{12}A_7$ increased when the specimens were fired at the temperatures 600 °C – 900 °C and decreased after 950 °C. It can be notice that CA intensively crystallizes in the composition after firing at 900 °C.

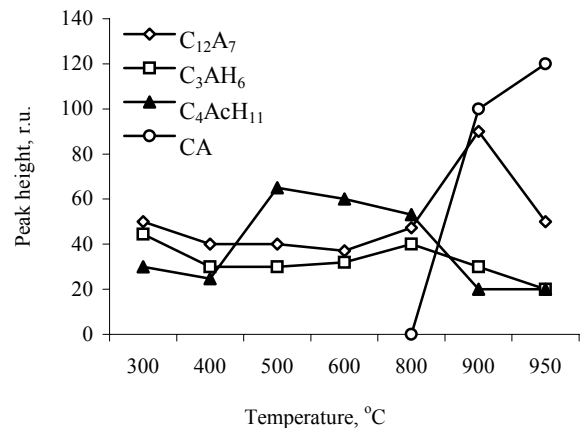
Fig. 4. Changes of peak height of minerals (C_3AH_6 ($d = 0.229$ nm), $C_{12}A_7$ ($d = 0.220$ nm), C_4AcH_{11} ($d = 0.76$ nm) and CA ($d = 0.297$ nm)) representative peak after firing and curing in humid conditions

When the specimens are fired and cured in humid conditions, C_3AH_6 considerably increases and C_4AcH_{11} appears. It can be seen that C_3AH_6 persists up to 950 °C. The biggest amount of C_4AcH_{11} was identified in the interval of 500 °C – 800 °C temperatures. The higher amount of C_3AH_6 and newly formed C_4AcH_{11} in the specimens, which were cured in humid conditions, explains the lower amount of $C_{12}A_7$ in them (Fig. 4).

It can be concluded that $C_{12}A_7$ in humid conditions (as one of the most active minerals of cement) easily hydrates and carbonates further forming C_3AH_6 and C_4AcH_{11} . The volume of newly formed minerals is considerably higher than $C_{12}A_7$. It is obvious that cyclic changes (dehydration at high temperatures, repeated hydration and carbonation in humid conditions, and dehydration of carbonates) of

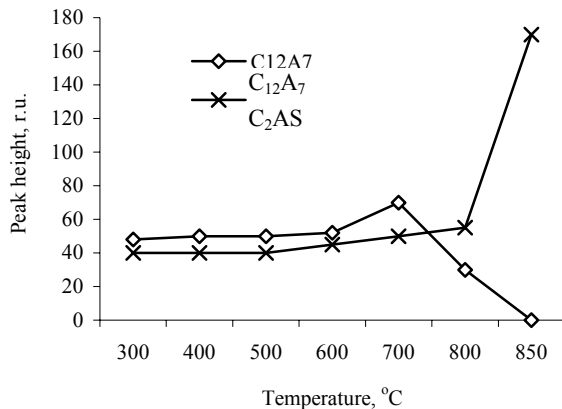
Fig. 5. Changes of peak height of minerals $C_{12}A_7$ ($d = 0.220$ nm) and C_2AS ($d = 0.285$ nm) representative peak after firing

After firing at the interval of 300 °C – 850 °C temperatures $C_{12}A_7$ and C_2AS were observed. The quantitative changes are reflected in Fig. 5. Unlike in hydrated cement paste (composition A) in fired specimens of composition B C_3AH_6 is not identified. $C_{12}A_7$ mineral in composition with the additive of microsilica forms according to this scheme [10]:

A small amount of CA_2 and CA also appears (these peaks are not shown in Fig. 5 and Fig. 6).

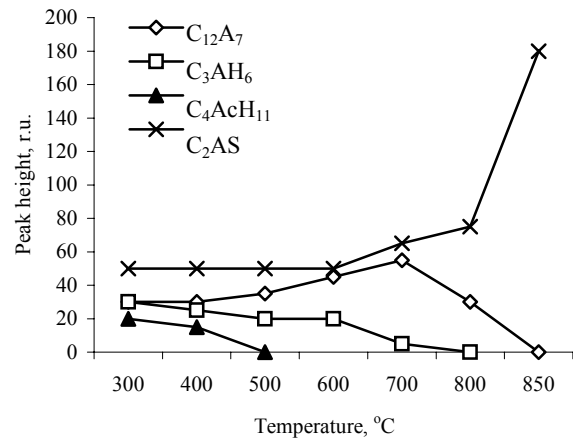
Fig. 6. Changes of peak height of minerals (C_3AH_6 ($d = 0.229$ nm), $C_{12}A_7$ ($d = 0.220$ nm), C_4AcH_{11} ($d = 0.76$ nm) and C_2AS ($d = 0.285$ nm) representative peak after firing and curing in humid conditions

In the specimens cured in humid conditions (Fig. 6) mineral C_3AH_6 forms, but it's amount is smaller than in the specimens of composition A. After firing at 800 °C this mineral is not found any more in the specimens cured in humid conditions.

C_4AcH_{11} mineral has not been identified in the fired specimens, but a small amount of it was found in the specimens that were cured in humid conditions, however, after firing at 500 °C it is not observed (Fig. 6).

After firing at 850 °C $C_{12}A_7$ has not been identified as well as amount of gehlenite considerably increased in any of the specimens (neither in fired nor in cured in humid conditions).
