Mechanical properties of solid glass bricks

Jiří Fíla¹, Martina Eliášová², Zdeněk Sokol³

Faculty of Civil Engineering, Czech Technical University in Prague, Prague, Czech Republic

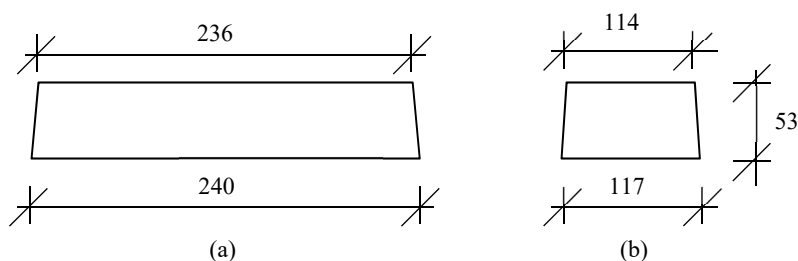
Figure 1. Geometrical dimensions of the brick: (a) – front view; (b) – side view

Over the past ten years, several buildings have been built using solid glass bricks. In most of these realizations the bricks do not fulfill the load-bearing function so additional supporting structure is needed. An exception is the Crystal House in Amsterdam (Oikonomopoulou, Bristogianni, Veer, & Nijse, 2017) and the Atocha Monument in Madrid (Christoph & Knut, 2008). These projects use custom-made bricks, whose price is undoubtedly higher than in mass production. At present, full glass bricks are marketed by two manufacturers (glass brick Poesia and Vetropieno), which differ slightly in color, surface finish and geometric dimensions.

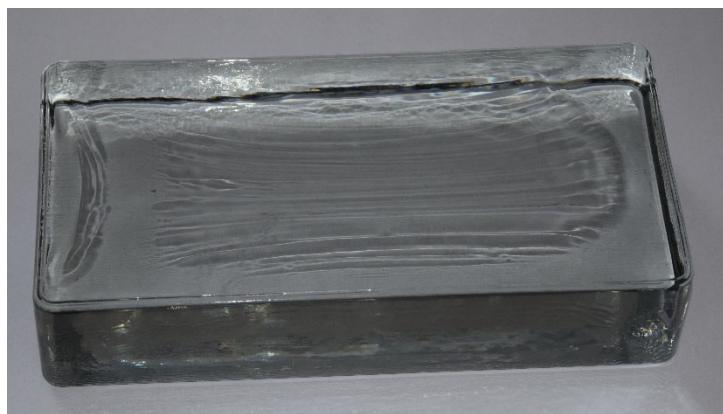
Figure 2. Solid glass brick

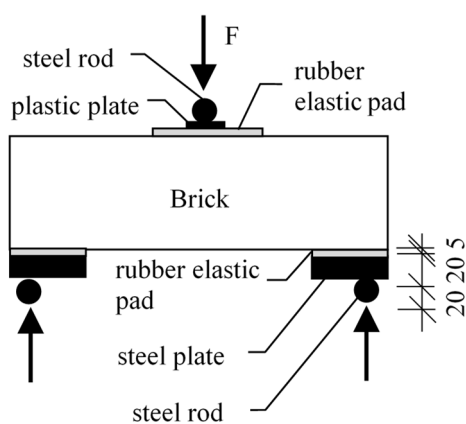
Figure 3. Test schema

Three-point bending test were done on MTS Qtest 100 testing machine (maximum load 100 kN). The tested brick was placed in the testing machine in horizontal position as shown in Figure 3 and Figure 4. Because of risk of the breakage due to the local peak stress, there were placed rubber pads between the glass brick and the supporting steel plate. The thickness of the rubber pads was 5 mm. The steel plates were supported by steel rods with diameter of 20 mm. The force was applied through the steel rod and plastic plate. The load point was in the middle of the span and the rubber pad was also placed between the steel and glass surface.

The vertical deformations over the supports were measured by linear variable displacement transducers (LVDTs). The displacement in the middle of the span was measured by laser extensometer. Real brick deflection was calculated by subtracting the average of support values from the middle-span value. In addition to the deflection measurement, normal stress in the middle of the span at the bottom side was determined. For this purpose strain gauges LY 11 10 / 120 were used, which were placed on the tensile surface of the test specimen. The loading was controlled by displacement and the loading rate was set to 0.5 mm/min. Totally six bricks were tested.

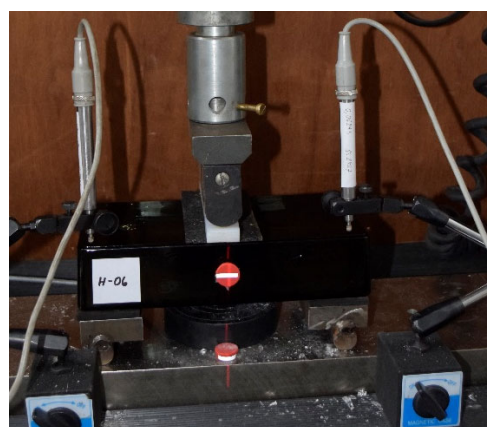
Figure 4. Specimen the testing machine

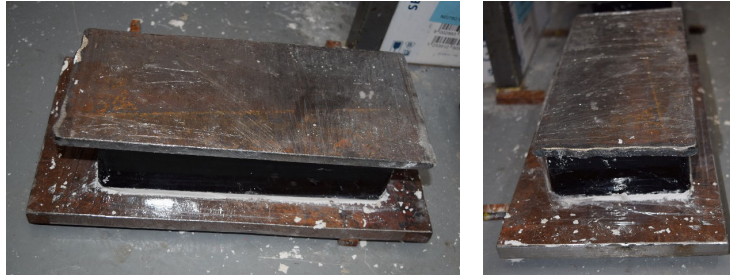
Figure 5. Compression test specimens

Compression test were done on VEB EDB 400 testing machine which can exert maximal force 4000 kN. Glass bricks have a concave upper surface due to shrinkage in the course of cooling during manufacturing, and their shape is tapered as mentioned above. Because of this it was necessary during the compression test to lay the brick in the gypsum bed on the bottom and top surfaces to obtain uniform stress redistribution. For easier and quicker handling, it was decided to place glass brick between steel plates, see Figure 5. Tests were made two weeks after preparing of the specimens. During the test, only the maximum force was measured. Figure 6 shows the specimen in the testing machine. The loading was controlled by displacement and the loading rate was set to 1 mm/min. Compressive strength is declared by the manufacturer, so this test was performed just for check of the declared parameter. Totally three specimens were tested.

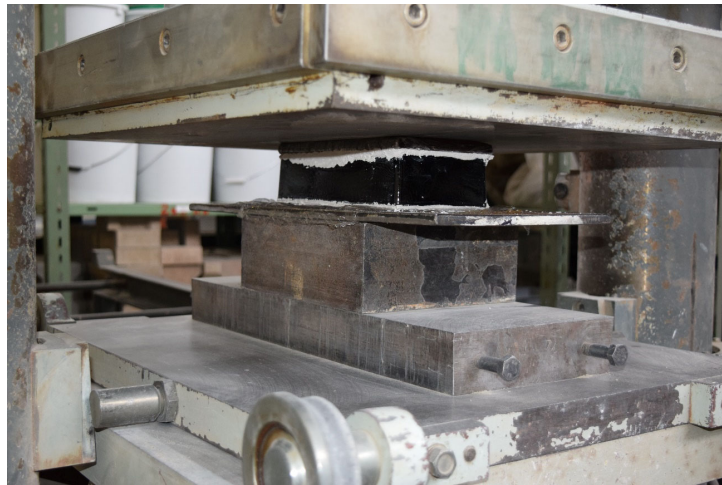
Figure 6. Test specimen in the testing machine

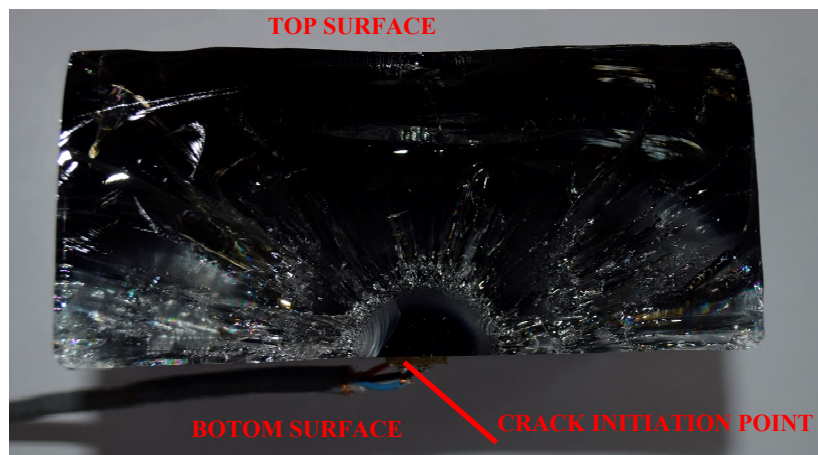
Figure 7. Example of a typical damage

Since the tensile strength of the glass is approximately ten times lower than the compressive strength, the crack always occurs on the tensile side of the test specimen as demonstrated by the performed experiments. In all cases a crack was created at the middle of the span, no crushing of the glass was observed near the supports neither near loading point, see Figure 7. The section modulus, used to determine tensile strength, was calculated after test from the dimensions measured in the rupture cross-section. The modulus of elasticity was calculated based on the values of the relative strains from the strain gauge and the deflection in the middle of the span. Figure 8 shows broken test specimens after test. Load-displacement diagrams for all tested bricks are in Figure 9. The results for all specimens are summarized in Table 1.

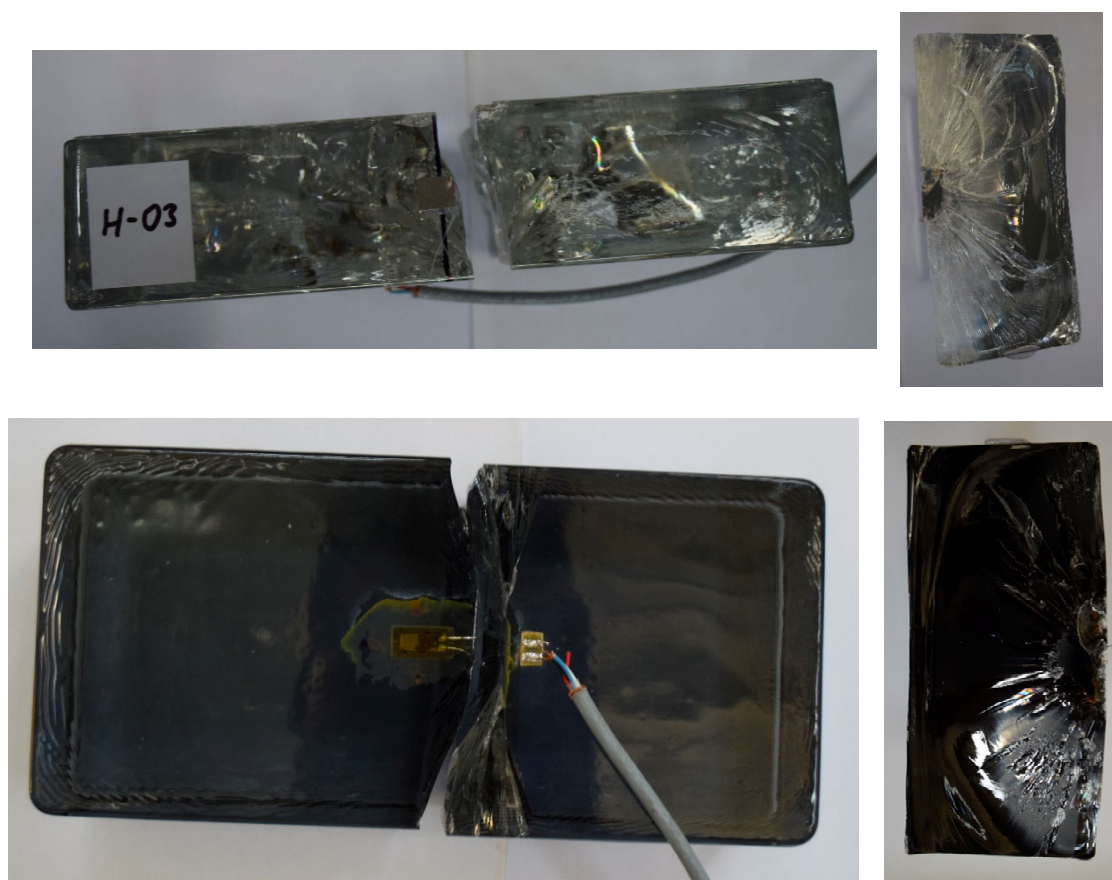
Figure 8. Specimens after test

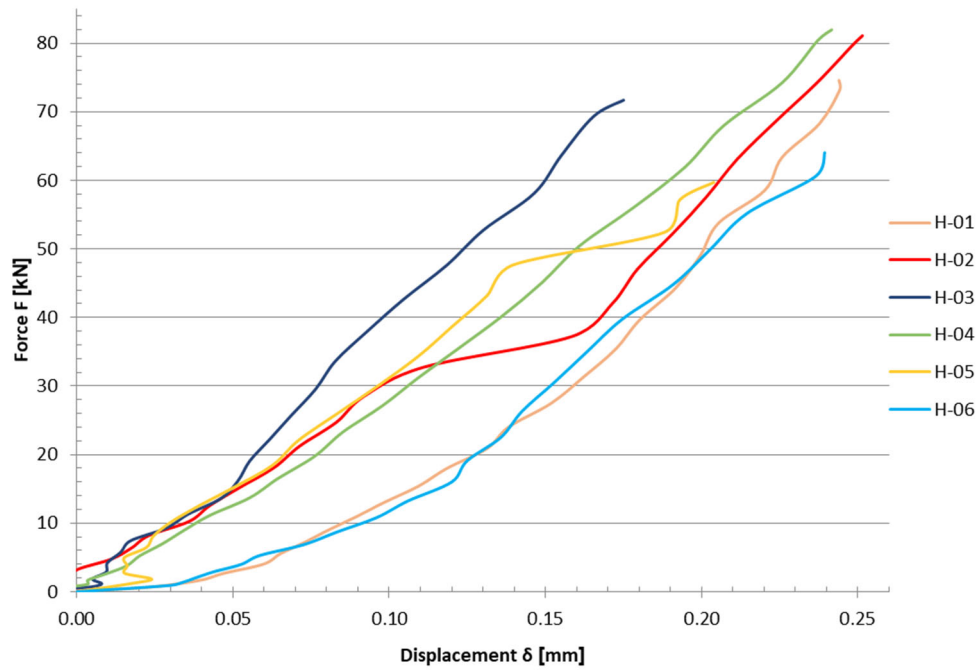
Figure 9. Load-displacement diagrams

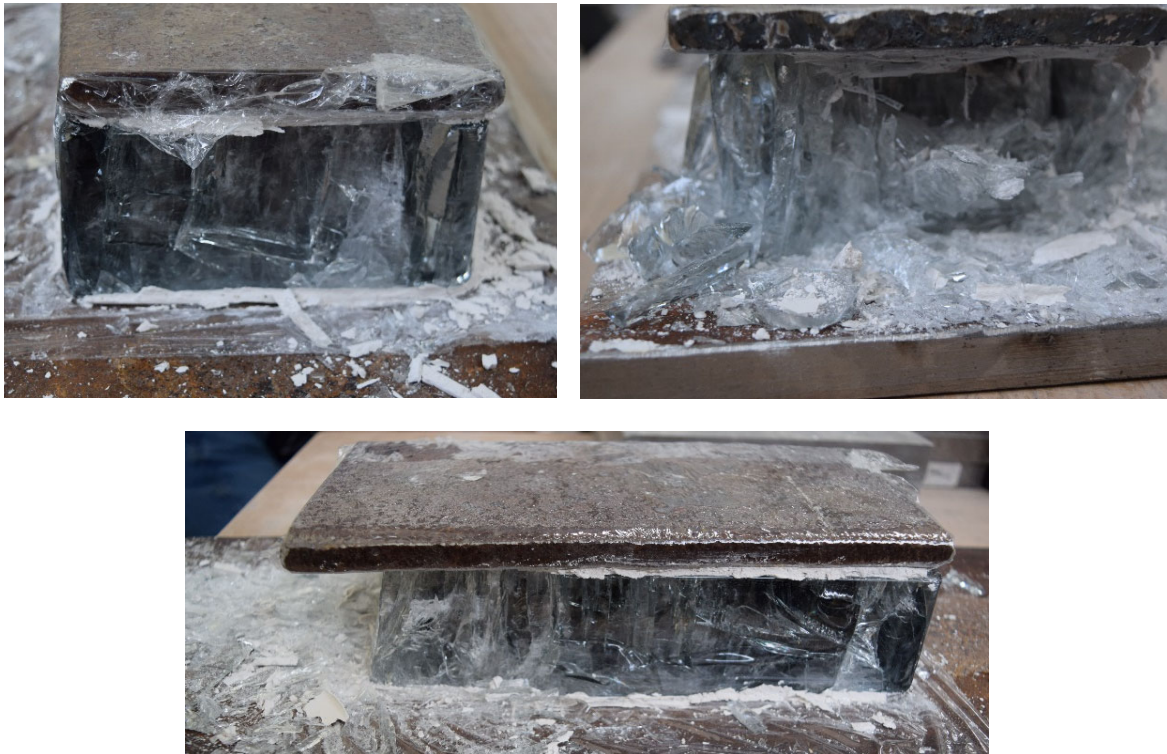
Figure 10. Specimens after test

Manufacturer of the glass bricks declare maximal compressive strength as 109 MPa. In all cases, the first break of the glass brick did not cause a reduction of the load force. After the first crack in the glass, the test specimen was further loaded. As the force increased, the cracks developed further until the brick collapsed. The test was terminated by disintegration of test specimens at maximum force. The results for all specimens are summarized in Table 2, where F_{fail} represents the forces in the formation of the first crack, and F_{max} the maximum force that was attained during the collapse. Figure 10 show the specimen after the compression test.
