CHANGES IN THE LANDSCAPE OF GEDIMINAS HILL'S SLOPES

Šarūnas SKUODIS*, Mykolas DAUGEVIČIUS, Neringa DIRGĖLIENĖ, Mindaugas ZAKARKA

Vilnius Gediminas Technical University, Vilnius, Lithuania

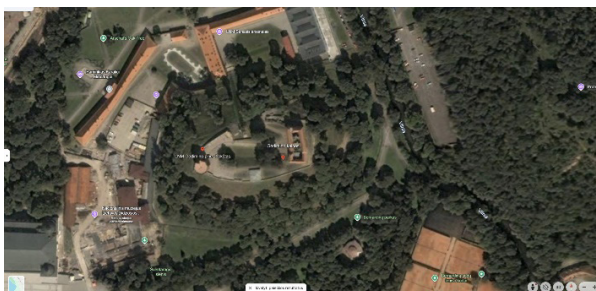
Figure 9. Gediminas Hill view in 10-07-2002 (Google Earth)

Contemporary analyses of landscape change at Gediminas Hill can be conducted using satellite imagery (e.g., Google Earth, n.d.). An early available image from 2002 (Figure 9) indicates that trees then covered nearly the entire Hill. In 2008 a landslide on the eastern slope of the Hill at the spring (Figure 10) was cleared, but the effects of this landslide are not visible because of the dense tree cover (Figure 11).

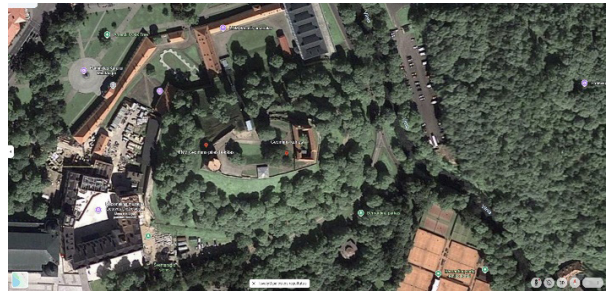
Figure 11. Gediminas Hill view in 03-08-2009 (Google Earth)

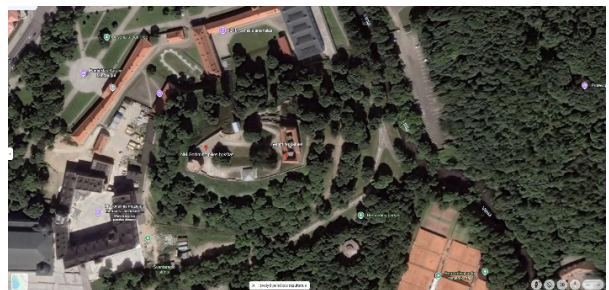
Figure 12. Gediminas Hill view in 05-06-2011 before tree removal (Google Earth)

All Vilnius city residents were used to seeing Gediminas Hill covered with trees (Figures 9, 11, 12), but in 2011 a decision was made to restore the Hill's authentic appearance, and tree removal from the slopes began (Figures 13, 14). Since grass does not grow under dense tree canopies, no adequate grass cover had developed after the trees were cut. Therefore, when trees were removed from the slopes of Gediminas Hill, three-year-old turf was laid to establish a stable vegetation cover (Figure 15).

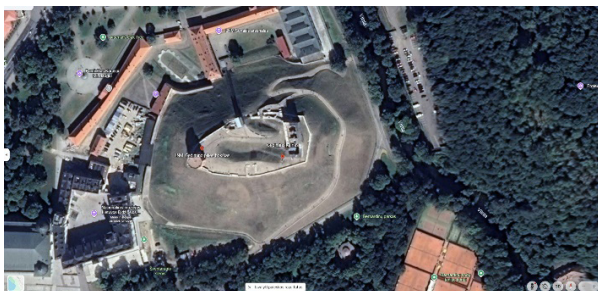
Figure 16. Gediminas Hill view in 13-08-2014 after tree removal (Google Earth)

Trees cutting continued until 2014 (Figure 16). The authentic view of Gediminas Hill's slopes did not last long, because the loss of root reinforcement (Skuodis & Ng, 2018) from trees caused the surface soil layers to begin sliding. First landslide appeared on 1 February 2016, under unfavourable meteorological conditions, a superficial landslide began to form on the northwest slope of Gediminas Hill. In the zone of thawed and waterlogged soil a sliding surface developed (Figure 17), and on 13 February 2016 the landslide moved downslope.

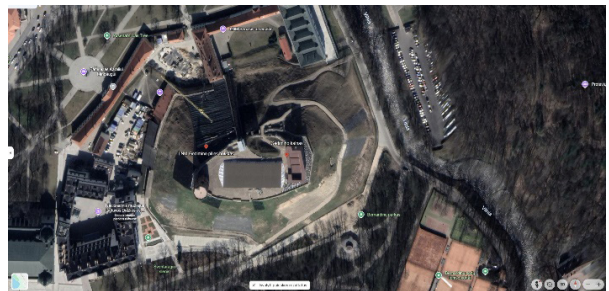
Figure 19. Gediminas Hill view in 13-04-2018 with gabions installation in northwest slope (Google Earth)

The restoration and reinforcement of the northwest slope were carried out using gabion structures (Figure 19). This method of slope stabilization is well suited for restoring the slope profile on steep sections of the Gediminas Hill.

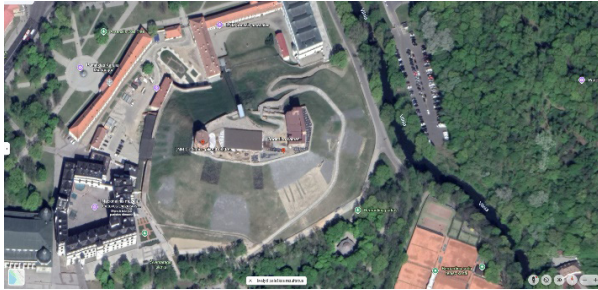
Figure 20. Gediminas Hill view in 30-04-2019 (Google Earth)

Despite the remediation works on the northern slope, shallow landslides occurred on other slopes (Figure 20). These landslide zones were treated with temporary measures, filling the landslide sites with crushed stone and covering them with anchored wire mesh.

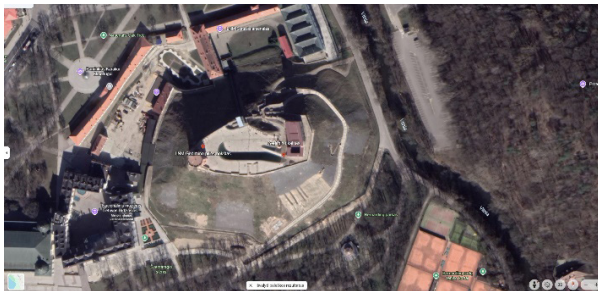
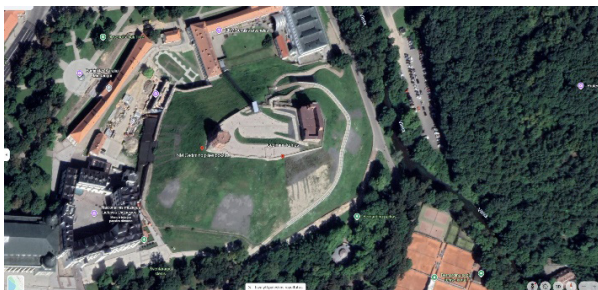
For the new shallow landslides that appeared during the 2020–2023 period, only temporary slope-stabilization measures were applied (Figures 21–23). Comprehensive slope remediation works began in November 2024 and, according to the slope restoration project, are scheduled to be completed in 2028.
