ASSESSMENT OF DEFECTS IN MASONRY WALLS FOR THE RESIDENTIAL BUILDINGS IN LITHUANIA

Abstract. This paper presents the assessment of masonry wall defects in residential buildings in Lithuania. The created model is based on a multi-attribute evaluation of wall defects in residential buildings in Lithuania, the determination of their optimality criterion values calculated according to Laplace's rule. The developed defect assessment algorithm has advantages to be used by repair contractors and people or companies performing building maintenance. First, the model allows planning the course of repair works properly. When carrying out repair work in a building with recurring defects that mainly occur at the building site, proper workflow and its planning are essential. The proposed model could be applied further to a building owner to select the most damaged walls. A background and a description of the proposed model are provided, and several key findings from the data analyses are presented.

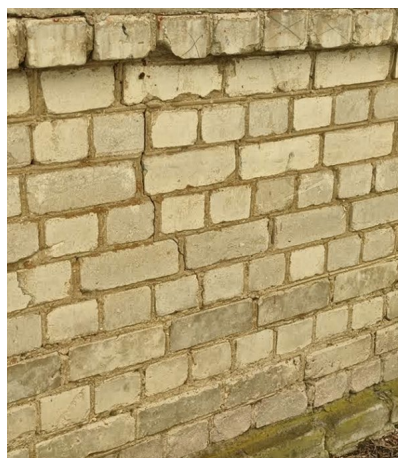
Figure 1. Defects in the movement of structures

- Movement or sedimentation of structures (Figure 1). As explained in scientific sources, the movement or deposition of structures produces cracks in masonry elements.

The leading cause of such cracks is the exceeded tensile strength of the masonry structure due to two factors:

- Factors directly affecting the masonry structure: gravitational forces, wind load, ground pressure;
- Factors indirectly affecting the masonry structure: environmental changes (temperature, humidity), deformations of load-bearing structures, and the stabilisation of the foundation (Martens & Vermeltoort, 2001).

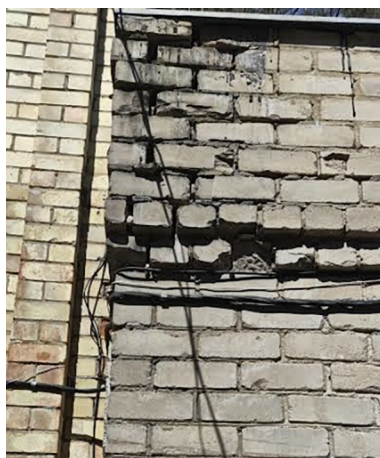
Figure 2. Defects in masonry walls due to inadequate drainage systems

Inadequate rainfall management systems (Figure 2). Based on various scientific sources, an inadequate drainage system (unsuitable rain barrier) allows the excess water to break down the joints in the masonry structure. This phenomenon occurs when water is not properly controlled or otherwise removed from the masonry structure. Water accumulates and washes the trace elements of the masonry structure, making the structure unstable (Kvande & Lisø, 2003).

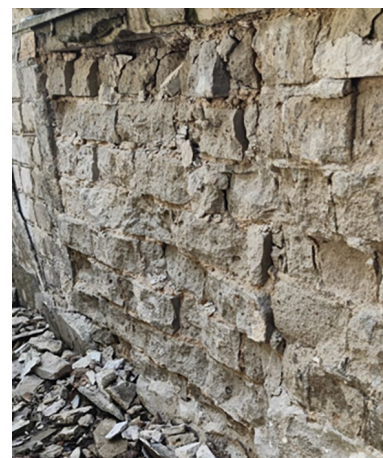
Figure 3. Developed algorithm for the assessment of defects

The poor-quality masonry elements are presented in Figure 3. They can be the reason behind a partial decomposition of the structure. Because masonry products are porous, they absorb water. As water turns into ice during the cold season, it presses on the pores' walls. Inadequately prepared masonry structure elements fail to withstand the

pressure, resulting in micro-cracks and cracks in the arc.

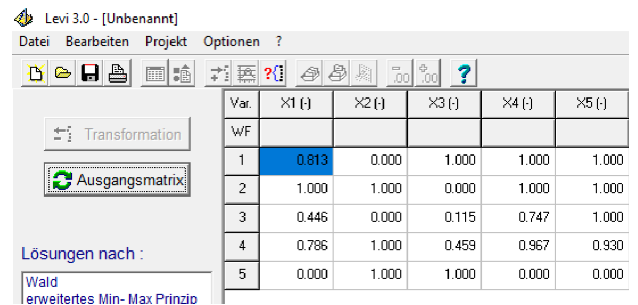
Figure 5. Normalised matrix

$$X_{ix} = \frac{A_{ij} - A_{ix}}{A_{ij} - A_{ik}}, \quad (4)$$

where A_{ij} is the maximum value of the indicator, A_{ik} is the minimum value of the indicator, A_{ix} is the normalised indicator. LEVI 3.0 software was used for all calculations (Zavadskas et al., 2002).

Dimensional quantities were obtained in the normalised matrix (Figure 5). These values continue to be used for the application of Laplace’s rule. Laplace’s rule is defined as the probability that all opponents’ strategies are the same. The line with the maximum amount is selected.

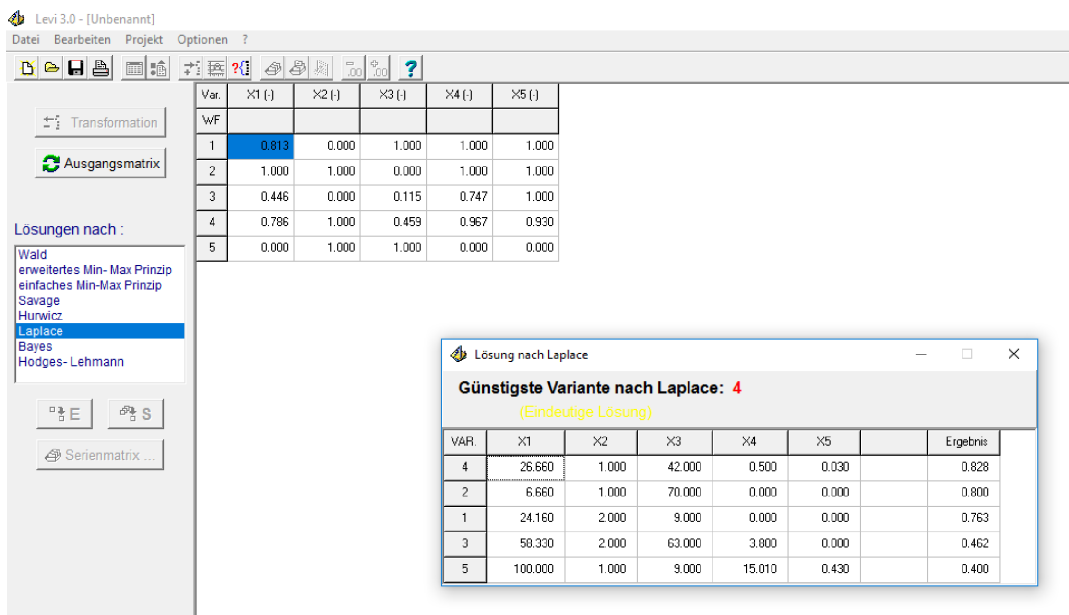
Figure 6. Results were obtained according to the Laplace's rule

Thus, calculations were performed, and results were obtained using the LEVI 3.0 software (Zavadskas et al., 2002) are presented in the Figure 6.

Based on the obtained results (Figure 6), when calculating with the LEVI 3.0 software, using Laplace’s rule, the priority order of repair works is as listed in Table 4.

The obtained results are shown in Table 3. The analysis of obtained results demonstrates that Case 3, which is the first case in the order of precedence, seems to be the worst, both according to the calculations using the Laplace’s rule and in general. According to the calculation results, the article’s authors recommend construction companies perform the work in the following sequence: Case 3, < Case 2, < Case 4, < Case 1, < Case 5. The priority line recommends the order in which the removal of masonry defects is necessary.
