# Soft Asphalt and Double Otta Seal—Self-Healing Sustainable Techniques for Low-Volume Gravel Road Rehabilitation

**Abstract:** Increased traffic flow on low-volume gravel roads and deficiencies of national road infrastructure, are increasingly apparent in Lithuania. Gravel roads do not comply with requirements, resulting in low driving comfort, longer travelling time, faster vehicle amortization, and dustiness. The control of dustiness is one of the most important road maintenance activities on gravel roads. Another important issue is the assurance of required driving comfort and safety. Soft asphalt and Otta Seal technologies were proposed as a sustainable solution for the improvement of low-volume roads in Lithuania. Five gravel roads were constructed with soft asphalt, and 13 gravel roads were sealed with double Otta Seal, in 2012. The main aim of this research was to check soft asphalt and double Otta Seal's ability to self-heal, on the basis of the results of the qualitative visual assessment of pavement defects and distress. The qualitative visual assessment was carried out twice a year following the opening of the rehabilitated road sections. The results confirmed soft asp

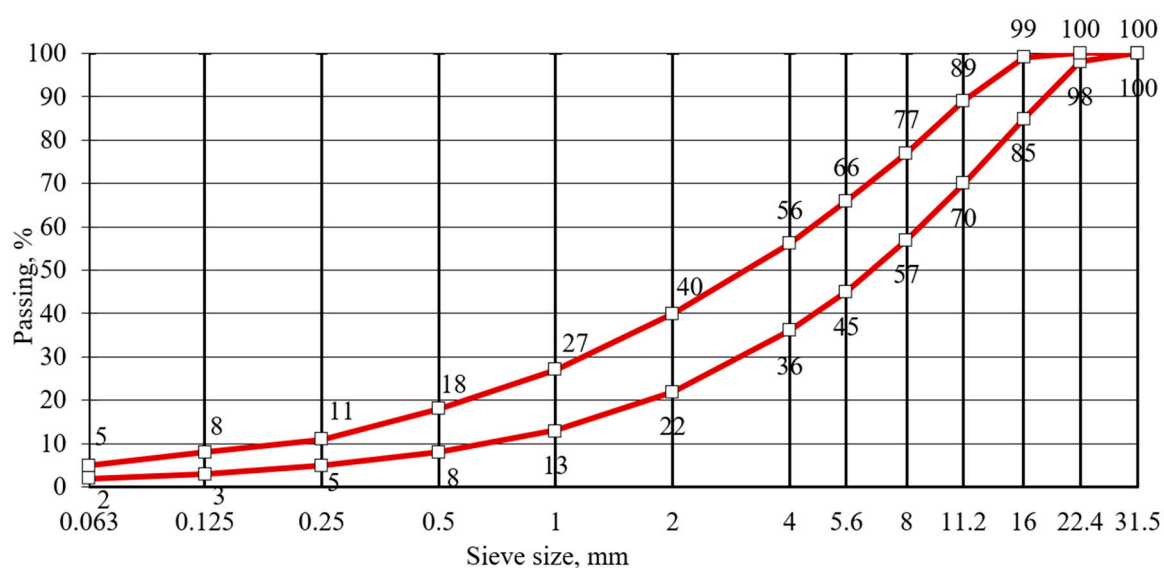
Figure 1. Aggregate gradation limits for double Otta Seal.

There were 0/16 fraction aggregates used, whose gradation limits are shown in Figure 1, and bitumen emulsion C60B1PA-V6000 or C60BF1-PA. The resistance to fragmentation, according to the impact resistance value (SZ), was  $\leq 18$ , and the Los Angeles coefficient (LA) was  $\leq 20$ . The recommended sprayed aggregate amount was 14 L/m<sup>2</sup>, but it could be corrected according to the aggregate spread test results. Adhesive additives and primes were not used. More information is given in [23].

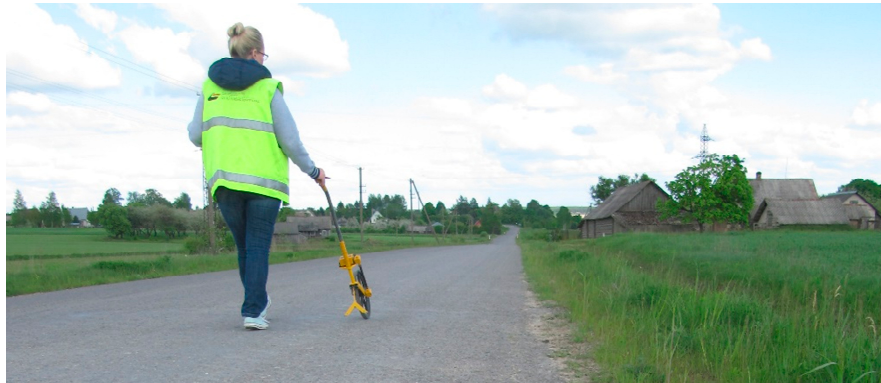
**Figure 2.** Measurement of crack length with a distance wheel.

expressed in percentages, as the ratio of the length of the cracks to the length of the road section. The length of longitudinal and transverse cracks was measured with a distance wheel (Figure 2).

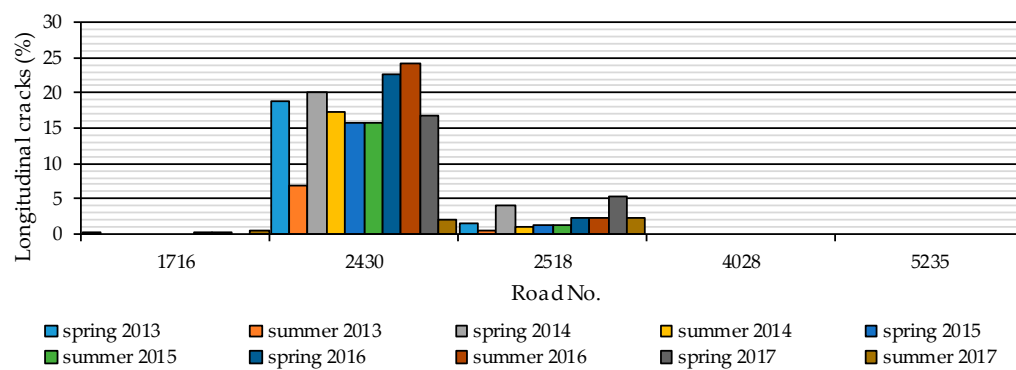
**Figure 3.** Longitudinal cracks on road sections covered with soft asphalt.

On road sections with soft asphalt, within five years of operation, longitudinal cracks, transverse cracks, bleeding, potholes, raveling, and seals, were observed. The extent of longitudinal cracks on each road section is shown in Figure 3. The most distressed road section was road no. 2430, where the average severity of longitudinal cracks was 10.00%. The maximum value of 24.10% and the lowest value of 2.16% on road no. 2430, were determined in summer 2016 and summer 2017, respectively. In summer 2013, the longitudinal cracks decreased by 62.98%. This reduction was a consequence of soft asphalt's ability to self-heal under high pavement temperatures. However, in summer 2014, longitudinal cracks showed lower self-healing than in the previous year (only 13.90%), and, in summer 2015, they did not change and even slightly increased (by 6.77%) in summer 2016. This happened because of a less warm summer in 2014, 2015, and 2016, than in 2013. In summer 2017, longitudinal cracks decreased by 87.23%, but the main reason was not soft-asphalt's ability to self-heal, since most of them were sealed during maintenance (Figure 4).

Similar tendencies for longitudinal crack development were observed on road No. 2518, where the maximum and the minimum values were 5.24% (spring 2017) and 0.39% (summer 2013), respectively. In summer 2013, 2014, and 2017, soft asphalt healed from 57% to 76% of longitudinal cracks. On road No. 1716, longitudinal cracks (0.07%) completely healed in summer 2013 and reappeared only in spring 2016 (0.35%). That summer, the length of longitudinal cracks neither increased nor decreased. However, it increased by 0.6% in summer 2017. On both roads (Nos. 4028 and 5235), longitudinal cracks had not yet formed.

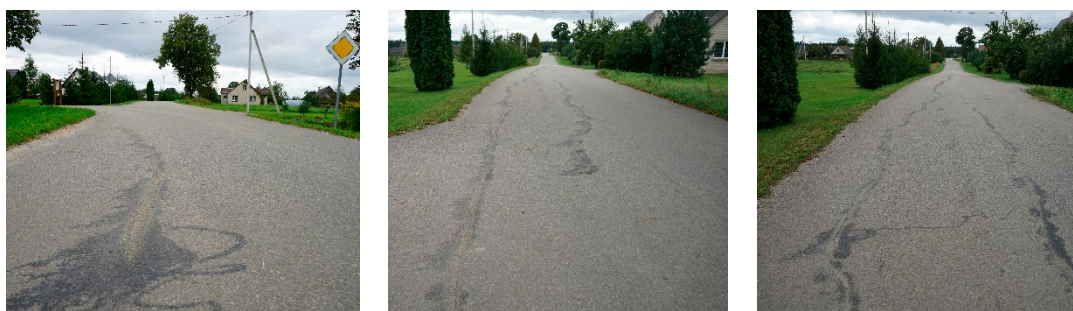
**Figure 4.** Sealed longitudinal cracks on road No. 2430 in summer 2017.

An analysis of longitudinal and transverse cracks revealed the road sections that performed the best and the worst. Roads No. 1716, 4028, and 5235, were the most resistant to cracking (Figure 7), while roads No. 2430 and 2518 suffered from longitudinal and transverse cracking (Figures 4 and 6) independently of both AADT and ESALs. It was noticed that longitudinal cracking was 10 to 13 times more severe than transverse cracking. Fortunately, soft asphalt's ability to self-heal contributed to the slower development of both longitudinal and transverse cracks and led to lower

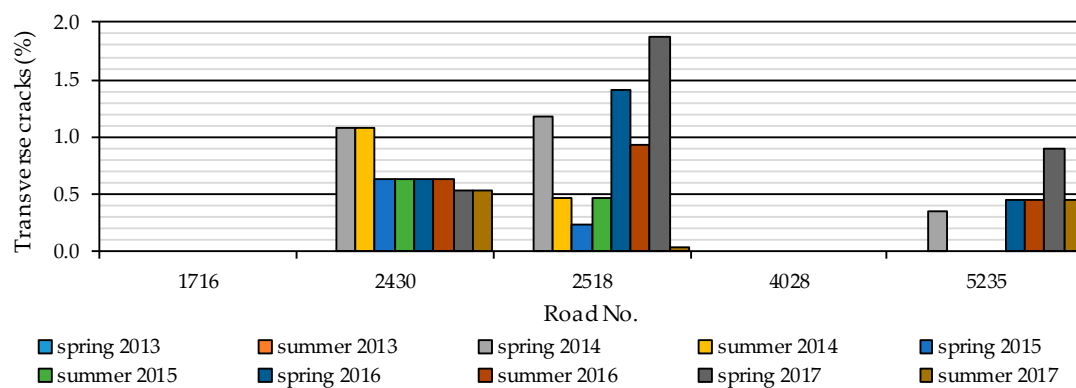
**Figure 5.** Transverse cracks on road sections covered with soft asphalt.

The extent of transverse cracks on each road section is depicted in Figure 5. Transverse cracks appeared one year after soft asphalt construction (after winter 2013/2014). The most distressed road sections were roads No. 2430 and 2518 (Figure 6). The maximum value of 1.88% was determined on road No. 2518 in spring 2017. On this road, in 2014, 2016, and 2017, the length of transverse cracks decreased by 33–98% because of soft asphalt's ability to self-heal under high pavement temperatures. However, in summer 2015, twice as many transverse cracks were observed than in spring. This, as well as the tendency of longitudinal cracks to develop on road No. 2430, is strange because transverse cracks usually occur after winter and do not increase during summer. Sometimes, at high temperatures, they can disappear, but only if the wearing course has self-healing properties. On road No. 5235, transverse cracks (0.35%) completely healed in summer 2014 and reappeared only in spring 2016 (0.45%). That summer, the length of transverse cracks neither increased nor decreased. However, they almost doubled in length in spring 2017 and, in summer, decreased to their previous length (0.45%). On both roads (Nos. 1716 and 4028), transverse cracks had not yet formed.

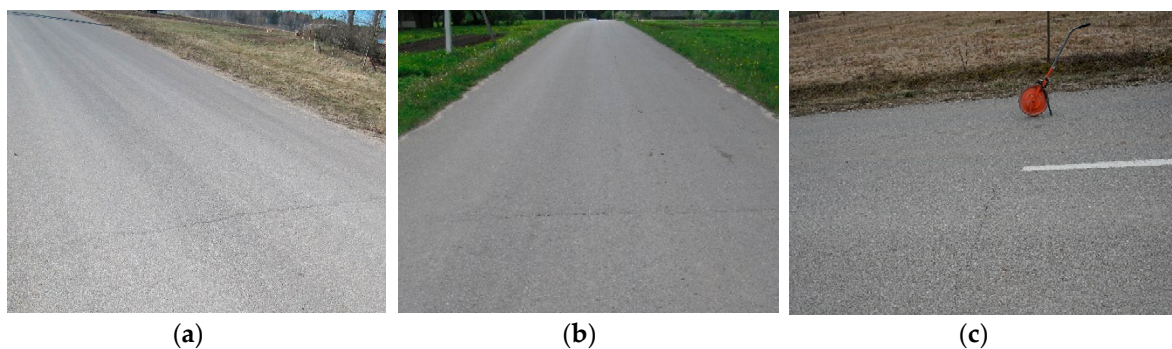
**Figure 6.** Transverse cracks on road sections covered with soft asphalt: (a) road No. 2430 in spring 2014; (b) road No. 2430 in spring 2016; (c) road No. 2518 in spring 2017.

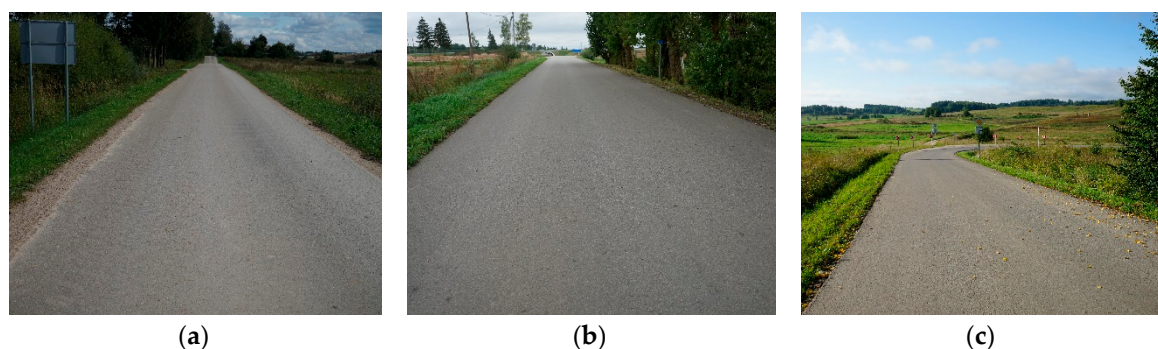
**Figure 7.** Road sections that showed the best performance after 5 years of operation: (a) road No. 1716; (b) road No. 4028; (c) road No. 5235.

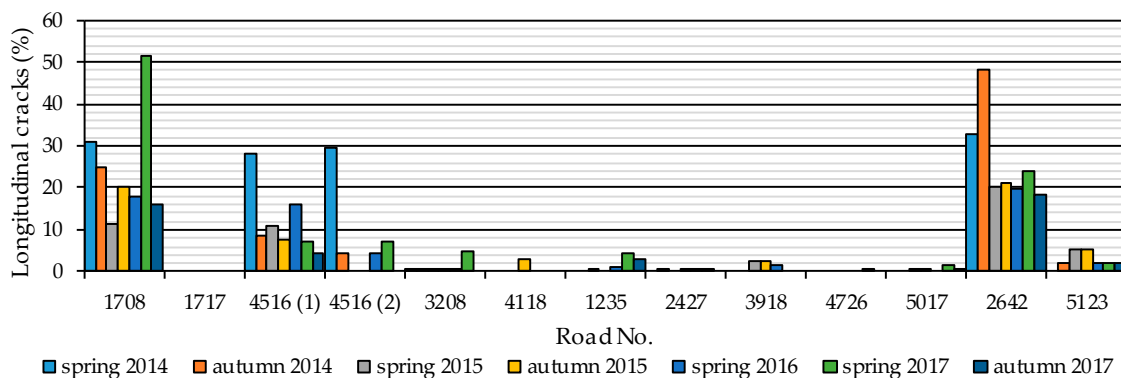
Figure 8. Longitudinal cracks on road sections covered with double Otta Seal.

and distress, were observed. The extent of longitudinal cracks on each road section is shown in Figure 8. This distress was observed from spring 2014. The most distressed road sections were roads no. 1708, 4516(1), and 2642, where the average length of longitudinal cracks on each road, within five years of operation, was 24.62%, 11.83%, and 26.41%, respectively (Figure 9). The maximum value of 51.54% was determined in spring 2017 on road no. 1708. Such a huge development of longitudinal cracks occurred because of frost heaves and low bearing capacity during the spring thaw. On four roads (Nos. 4516(2), 3208, 1235, and 5123) the average length of longitudinal cracks within five years of operation varied from 1% to 7%. Other roads were not prone to the development of longitudinal cracks, because cracks appeared on less than 1% of road length. On some roads (e.g., Nos. 1708, 4516(1), 4516(2), 3208, 2427, 4726, and 5017), in autumn, fewer longitudinal cracks appeared than in spring because a soft bitumen was used for emulsion production, which resulted in pavement self-healing under high pavement temperatures, and thus some cracks healed during summer. However, some anomalies were observed on roads No. 1708, 3208, 2642, and 5123, in 2014 and 2015, since more longitudinal cracks were determined in autumn than in spring, which was unexpected.

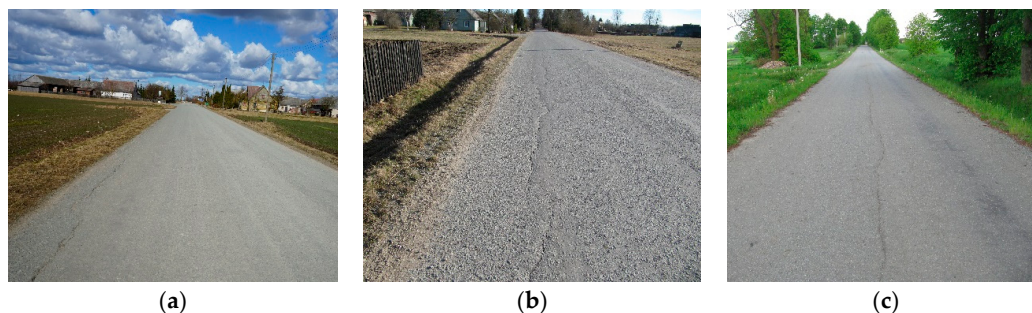
Figure 9. Longitudinal cracks on road sections covered with double Otta Seal: (a) road No. 1708 in spring 2017; (b) road No. 4516(1) in spring 2014; (c) road No. 2642 in spring 2016.

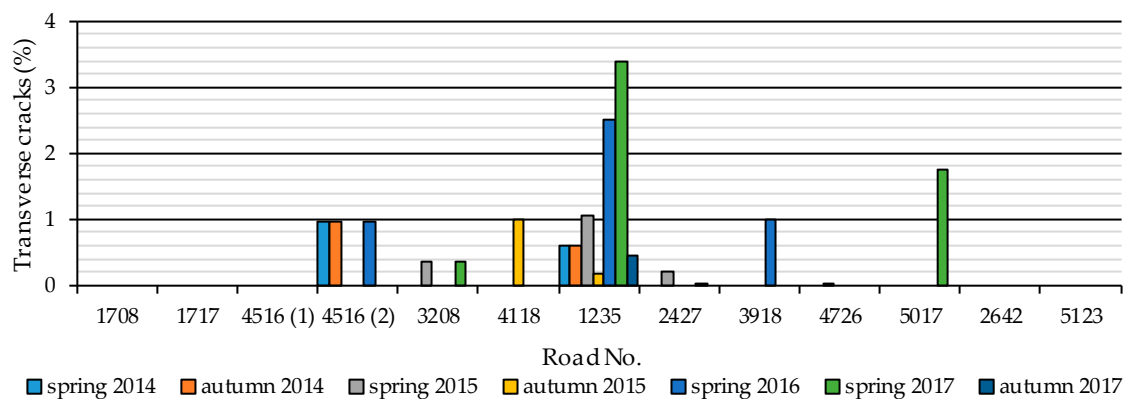
**Figure 10.** Transverse cracks on road sections covered with double Otta Seal.

The extent of transverse cracks on each road section is shown in Figure 10. This distress was observed from spring 2014. The most distressed road section was road no. 1235, where the average length of transverse cracks within five years of operation was 1.75% (Figure 11). It was emphasized that, on this road section, more than 85% less transverse cracks were determined in autumn than in spring. A similar tendency, of a decrease in transverse cracks, was also observed on other roads (e.g., Nos. 4516(1), 4516(2), 3208, 4726, and 5017). Hence, on the roads covered with double Otta Seal, transverse cracks self-healed under high pavement temperatures. The maximum value of 4.19% of transverse cracks was determined in spring 2014 on road No. 5017. Four roads (Nos. 1708, 1717, 2642, and 5123) were resistant to the development of transverse cracks, since within five years of operation no transverse cracks appeared. On other roads, the average of transverse cracks within five years of operation was less than 1%.

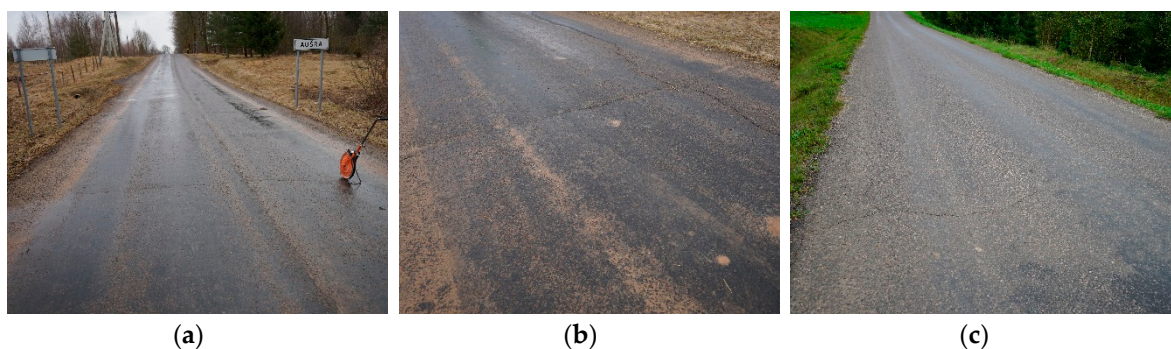
**Figure 11.** Transverse cracks on road No. 1235: (a) in spring 2017; (b) in spring 2017; (c) in autumn 2017.

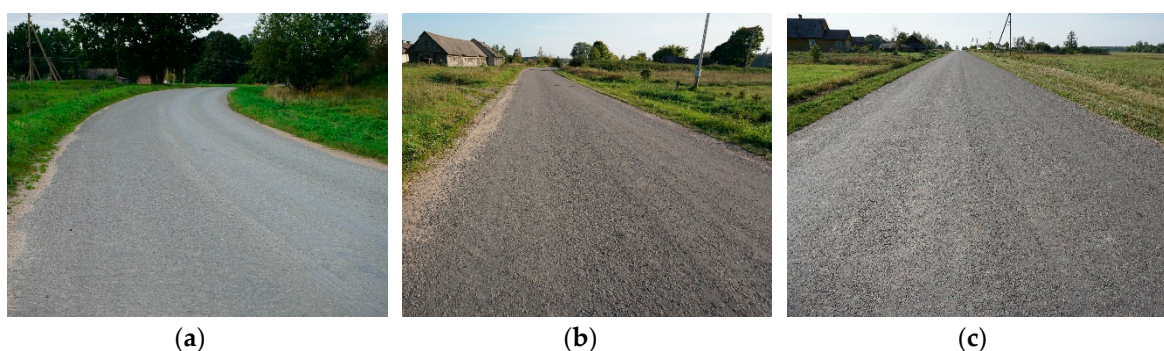
**Figure 12.** Road sections that showed the best performance after 5 years of operation: (a) road No. 4118; (b) road No. 4726; (c) road No. 5017.

An analysis of longitudinal and transverse cracks revealed the road sections that performed the best and the worst. Roads No. 1717, 4118, 2427, 3918, 4726, and 5017, were the most resistant to cracking (Figure 12), since the average of both longitudinal and transverse cracks within five years of operation was less than 1%, while roads No. 1708, 4516(1), 1235, and 2642, suffered from longitudinal or transverse cracking (Figures 9 and 11). The severity of cracking did not depend on AADT and ESALs on test roads. It was noticed that longitudinal cracking was 12 to 25 times more severe than transverse cracking. Fortunately, double Otta Seal's ability to self-heal contributed to the slower development of both longitudinal and transverse cracks and led to lower pavement susceptibility to frost heaves, fatigue, and low temperatures.
