Identification of Reactivity Level in Aggregates from Lithuanian Gravel Quarry

Aurimas Rutkauskas¹, Džigita Nagrockienė², Gintautas Skripkiūnas³, Asta Kičaitė⁴, Giedrius Girskas⁵
^{1–5} *Vilnius Gediminas Technical University, Vilnius, Lithuania*

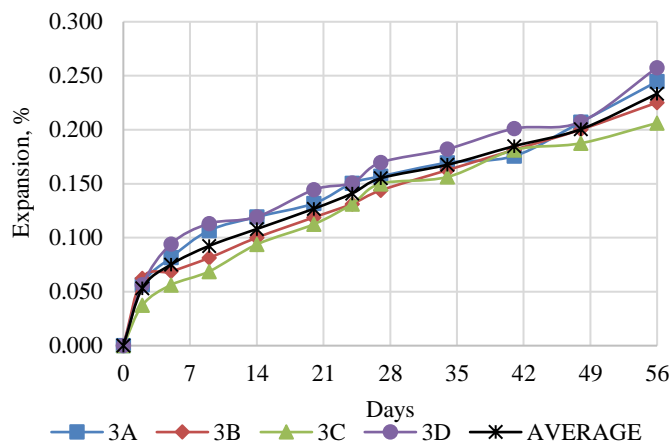
Fig. 5. Expansion of mortar prisms with the second type of gravel (to Day 56). Mix III.

The test results of the specimens made of Mix III with another type of gravel are presented in Fig 5. The tests showed that expansion after 14 days of storing in 1 M NaOH increased: the average elongation was 0.23 mm, and the average expansion was 0.11 %. After 56 days the average elongation was 0.42 mm, and the average expansion was 0.23 %. According to the test results, this gravel is also a very likely to be alkali-reactive aggregate.

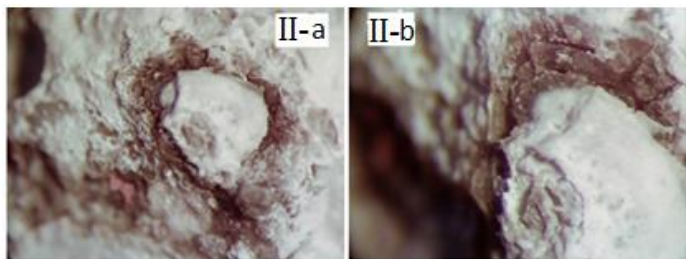
Optical microscopy testing of the specimens revealed the contact zones of hardened cement paste and cracked surface. The microscopy images of the zones, where alkali corrosion reaction occurred, revealed a rough and cracked surface with clearly seen reacted particles (Fig. 7 and 8). The reaction products in the figure are white.

Fig. 7. Fragment of Mix II specimen. The contact zone of the hardened cement paste and aggregate is cracked (image of optical microscopy, image increased: a) $\times 25$; b) $\times 50$).

Figures 7 and 8 illustrate that alkali corrosion reaction, i.e. reaction products, caused a significant deterioration of the prisms, especially those made of Mix II and III. Alkali corrosion reaction involves three components: amorphous watery and cryptocrystalline SiO₂ (opoka, opal and flint), sodium and potassium hydroxide (alkali) and calcium hydroxide (portlandite). Deteriorated surface of the coarse aggregate is shown in the pictures. The coarse aggregate is surrounded by the zone of reaction products. This zone is very porous and has a great amount of glass phase. Behind the reaction product zone there is a hardened cement paste matrix, where reaction products are also seen.

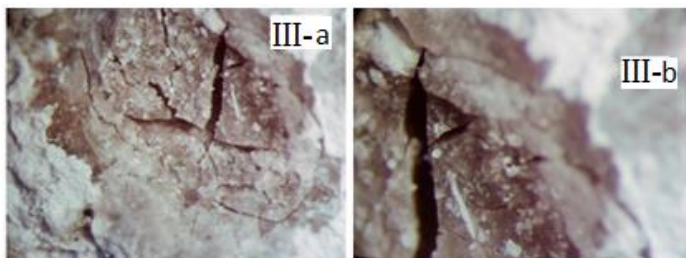
Fig. 8. Fragment of Mix III specimen. The contact zone of the hardened cement paste and aggregate is cracked (image of optical microscopy, image increased a) $\times 25$; b) $\times 50$).
