# Identification of Reactivity Level in Aggregates from Lithuanian Gravel Quarry

**Abstract** – The article analyses the reactivity level of aggregates from Lithuanian quarries and their effect on the alkali corrosion in mortars. The reactivity of aggregates was assessed according to Rilem Recommended Test Method: AAR-2. The hardened cement paste and cracked aggregate contact zones were tested by means of optical microscopy. Two gravel aggregates and one sand aggregate from Lithuanian quarries were selected for testing. The tests revealed that according to AAR 2 methodology fine and coarse aggregates from Lithuanian quarries shall be allocated to Group II, i.e. reactive aggregates. The expansion after 14 days exceeds 0.1 % in the case of fine aggregate, the average expansion after 14 days is 0.13 %, and in the case of coarse aggregates the average expansion ranges from 0.11 % to 0.12 %.

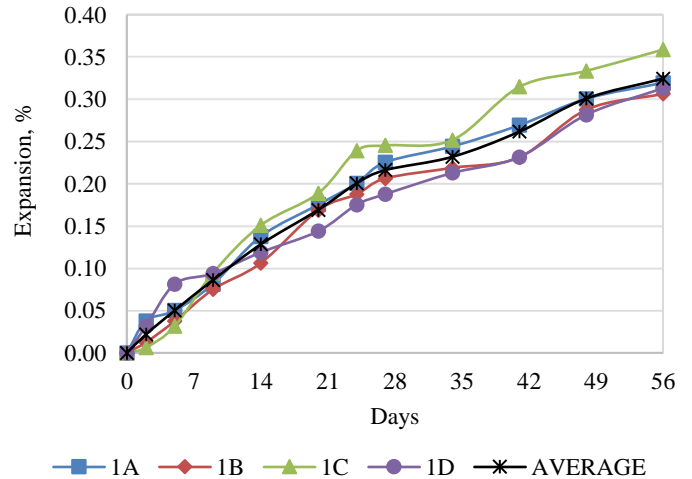
Figure 1 illustrates the results of the expansion test in the specimens with sand (Mix I). After 14 days of storing in 1 M NaOH solution the average elongation of the prisms was 0.2 mm, and expansion was 0.13 %. As observed in Figure 1, the elongation of prisms with sand is even, in contrast to the prisms with gravel. Sand is considered a very likely to be alkali-reactive aggregate. Compared to the specimens with coarse aggregates, the expansion of the specimens with sand is greater. After 56 days of storing the average elongation of the prisms is 0.51 mm, and the expansion is 0.32 %.

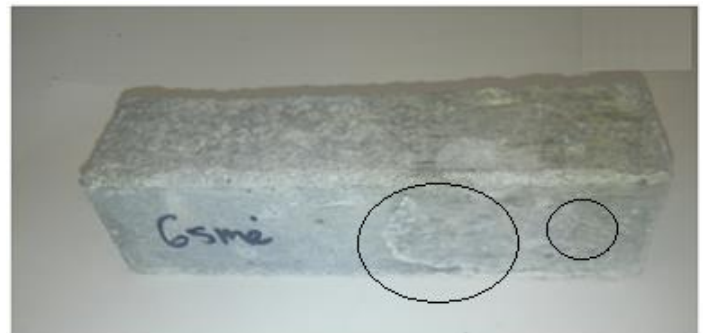
Fig. 2. Pictures of the sample (Mix I) after 56 days of storing in 1 M NaOH solution.

The picture of the specimen made of Mix I after 56 days of storing in 1 M NaOH is presented in Fig. 2. More significant damage occurred only on the surface of the specimen. The observed cobweb, micro-cracking and gel scales on the surface are the indicators of alkali corrosion. The scales result from the leaching of alkali and silica gel or calcium hydroxide (or both) from the cracked hardened cement paste. Intensive expansion of the prisms (Mix I) stored in 1 M NaOH alkali solution at 80 °C temperature occurs. Alkaline silica gel is the reason of destruction. Interactive destruction occurs in the mortar. Surface micro-cracking characteristic of alkali corrosion is observed. After 56 days of storing all prisms are damaged.

destructions. The extension is caused by alkaline silica gel. The interaction of mortar particles is disturbed and that is the reason of local spalling. Surface flaking is clearly seen in Figures 4 and 6.

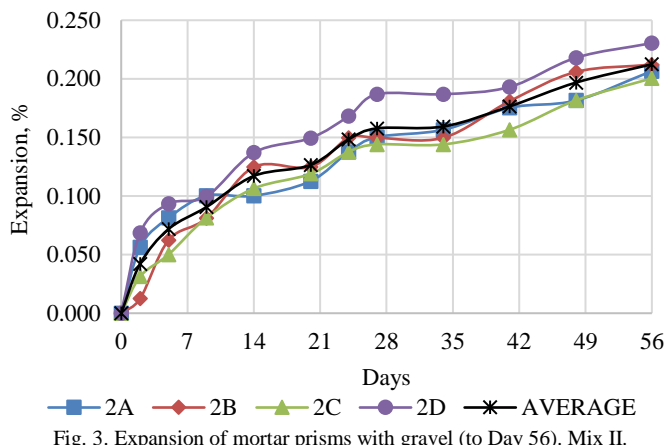
Fig. 3. Expansion of mortar prisms with gravel (to Day 56). Mix II.

The testing results of prisms made of Mix II are presented in Fig. 3. After 14 days the average expansion of the prisms is 0.12 %.

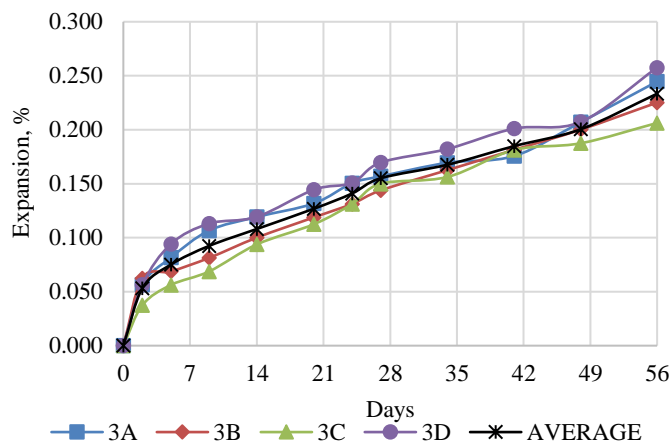
Fig. 5. Expansion of mortar prisms with the second type of gravel (to Day 56). Mix III.

The test results of the specimens made of Mix III with another type of gravel are presented in Fig 5. The tests showed that expansion after 14 days of storing in 1 M NaOH increased: the average elongation was 0.23 mm, and the average expansion was 0.11 %. After 56 days the average elongation was 0.42 mm, and the average expansion was 0.23 %. According to the test results, this gravel is also a very likely to be alkali-reactive aggregate.

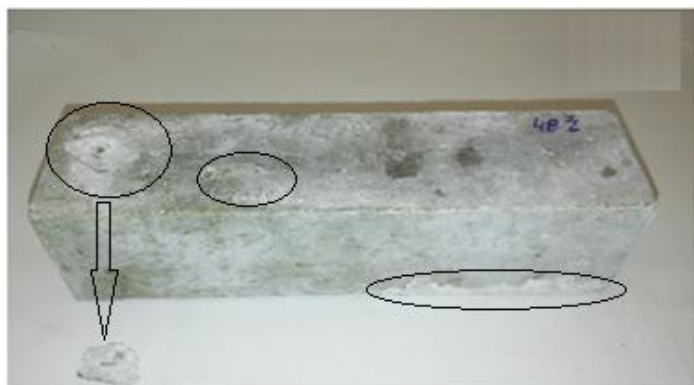
Fig. 4. Pictures of the sample (Mix II) after 56 days of storing in 1 M NaOH solution.

The picture of the specimen made of Mix II after 56 days of storing in 1 M NaOH solution is presented in Fig. 4. Visual inspection revealed surface flaking, the contact zone of flakes and hardened cement paste, micro-cracking and gel scaling on the surface. The average elongation of the prisms was 0.36 mm, and the average extension was 0.21 %. The tests revealed that gravel is a very likely to be alkali-reactive aggregate.

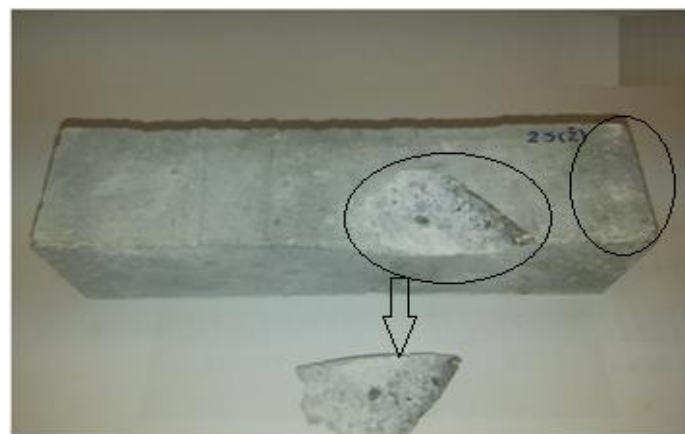
Fig. 6. Pictures of the sample (Mix III) after 56 days of storing in 1 M NaOH solution.

The picture of the specimen made of Mix III after 56 days of storing in 1 M NaOH is presented in Fig. 6. The expansion resulting from alkali and aggregate reaction on the surface of concrete causes the breaking of cone-shaped parts of the surface above the aggregate, leaving the recess of unprotected reactive aggregate. The chipped-off cone-shaped recess is seen below the prism.

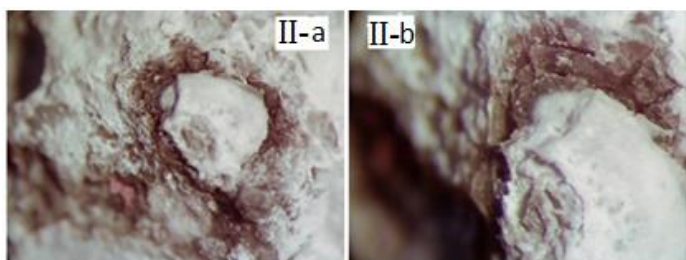
Fig. 7. Fragment of Mix II specimen. The contact zone of the hardened cement paste and aggregate is cracked (image of optical microscopy, image increased: a)  $\times 25$ ; b)  $\times 50$ ).

Optical microscopy testing of the specimens revealed the contact zones of hardened cement paste and cracked surface. The microscopy images of the zones, where alkali corrosion reaction occurred, revealed a rough and cracked surface with clearly seen reacted particles (Fig. 7 and 8). The reaction products in the figure are white.

Figures 7 and 8 illustrate that alkali corrosion reaction, i.e. reaction products, caused a significant deterioration of the prisms, especially those made of Mix II and III. Alkali corrosion reaction involves three components: amorphous watery and cryptocrystalline SiO<sub>2</sub> (opoka, opal and flint), sodium and potassium hydroxide (alkali) and calcium hydroxide (portlandite). Deteriorated surface of the coarse aggregate is shown in the pictures. The coarse aggregate is surrounded by the zone of reaction products. This zone is very porous and has a great amount of glass phase. Behind the reaction product zone there is a hardened cement paste matrix, where reaction products are also seen.

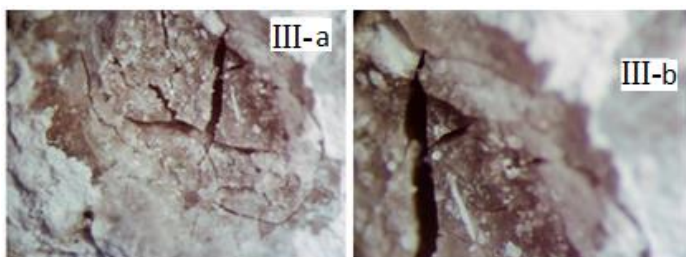
Fig. 8. Fragment of Mix III specimen. The contact zone of the hardened cement paste and aggregate is cracked (image of optical microscopy, image increased a)  $\times 25$ ; b)  $\times 50$ ).
