Determining Reactivity Level of Granite Aggregate for Concrete

Aurimas Rutkauskas¹, Džigita Nagrockienė², Gintautas Skripkiūnas³, Kęstutis Barkauskas⁴
¹⁻⁴ Vilnius Gediminas Technical University, Vilnius, Lithuania

Abstract – Granite rubble is one of the most frequently used aggregates in concrete manufacturing. Granite rubble is considered to be a non-reactive aggregate, however, depending on the quarry, granite may have various impurities including harmful minerals containing active SiO₂. The alkali – silica reaction is among the chemical reactions that have a significant effect on the durability of concrete. During the alkali – silica reaction certain forms of silica present in concrete aggregates react with high alkali content leading to formation of hygroscopic gel that expands in humid environment and slowly, although strongly enough degrades concrete structures. Concrete rubble of 3 different fractions was used for the test: 2/8 (Mix D); 11/16 (Mix E); 5/11 (Mix G). The tests revealed that granite rubble used for the tests contained few reactive rocks containing amorphous silica because after 14 days the expansion did not exceed 0.1 % (D Mix expanded by 0.059 %, E Mix expan

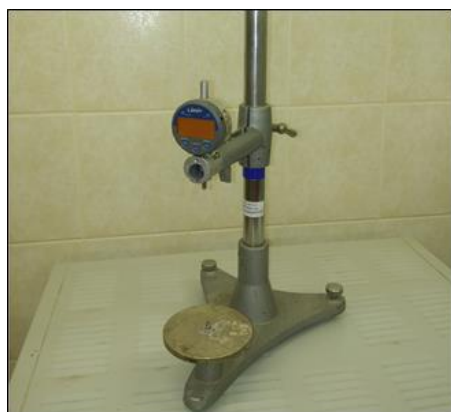
Fig. 1. Digital dial indicator and frame.

The elongation of specimens was measured by a digital dial indicator with the scale interval of 0.001 mm. The indicator is fixed in the frame (Fig. 1) where the prisms are placed. The frame and indicator axles are inserted into the moulded holes at the ends of the specimen.

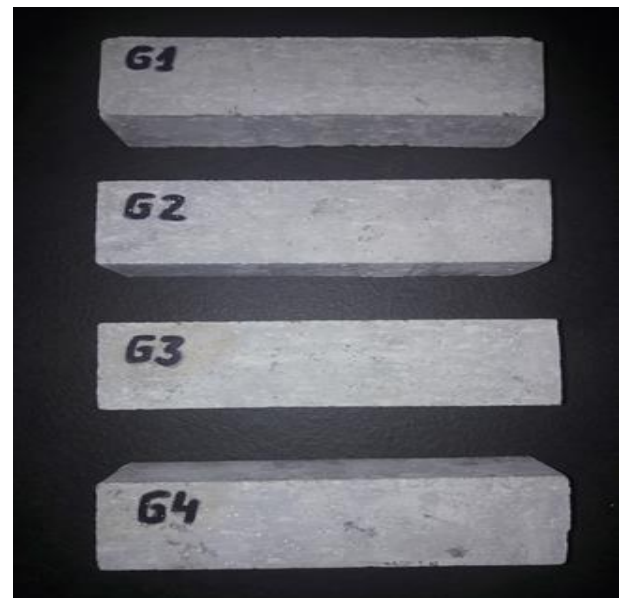
Fig. 9. Photos of specimens with granite rubble fr. 5/11 (Mix G) after 56 days soaking in 1 M NaOH solution.

The expansion of the specimens occurs when the prisms are immersed into 1M NaOH solution at 80 °C. The expansion is caused by the alkaline silica gel that develops in the specimen. Gel deposits on the surface were also observed on the specimens of Mix G; that is typical of alkali induced corrosion (Fig. 9). After 56 days of testing gel deposits on the surface of the rods was the only evidence of alkali induced corrosion; no surface cracking typical of alkaline induced corrosion was observed. Visual examination of the mortar bars did not reveal any surface damage; granite rubble (fr. 5/11) was not heavily contaminated with reactive rock that causes alkali induced corrosion and concrete degradation; therefore it can be classified as Class I – very unlikely to be alkali-reactive (expansion after 14 days according to AAR-2 < 0.10 %).
