# Determining Reactivity Level of Granite Aggregate for Concrete

Aurimas Rutkauskas<sup>1</sup>, Džigita Nagrockienė<sup>2</sup>, Gintautas Skripkiūnas<sup>3</sup>, Kęstutis Barkauskas<sup>4</sup>  
<sup>1-4</sup> Vilnius Gediminas Technical University, Vilnius, Lithuania

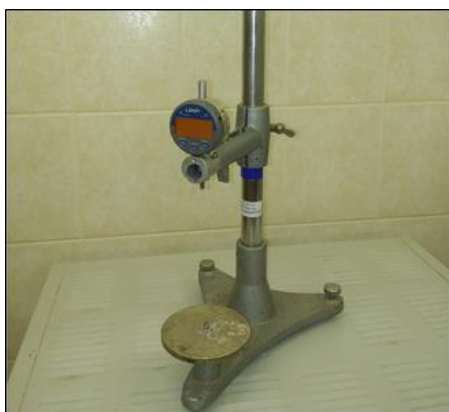
Fig. 1. Digital dial indicator and frame.

The elongation of specimens was measured by a digital dial indicator with the scale interval of 0.001 mm. The indicator is fixed in the frame (Fig. 1) where the prisms are placed. The frame and indicator axles are inserted into the moulded holes at the ends of the specimen.

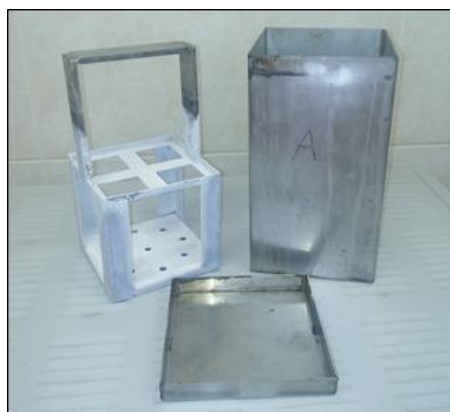
Fig. 2. Stainless steel container.

Four prisms with each aggregate were selected for the test. The length of the moulded prisms is measured and the prisms are immersed into water at 80 °C. After 24 hours the prism lengths are measured again (zero reading) and the specimens are placed into stainless steel containers (Fig. 2) with 1 M NaOH alkali solution at 80 °C.

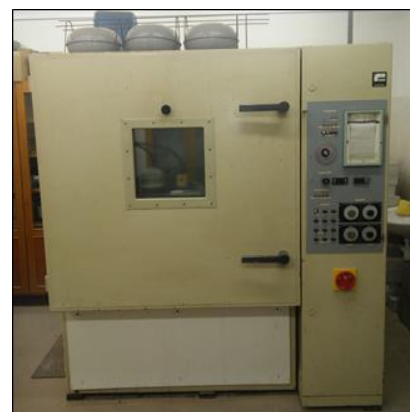
Fig. 3. Climatic chamber.

Containers with the specimens are placed into the climatic chamber (Fig. 3) where (80 ± 2) °C temperature is maintained. The elongation of specimens is measured regularly at the same hour of the day. When the specimens are removed after 24 ± 2 hardening in water at 80 °C temperature, the length, i.e. the zero reading ( $L_0$ ) is recorded; this is a reference reading for further measuring of specimen expansion. After the specimens are placed into 1 M NaOH alkaline solution at 80 °C, the specimen dimensions ( $L_n$ ) are recorded after 1, 3, 6, 9, 12, 14, 21, 28, 35, 42, 49, 56 days ± 2 hours.

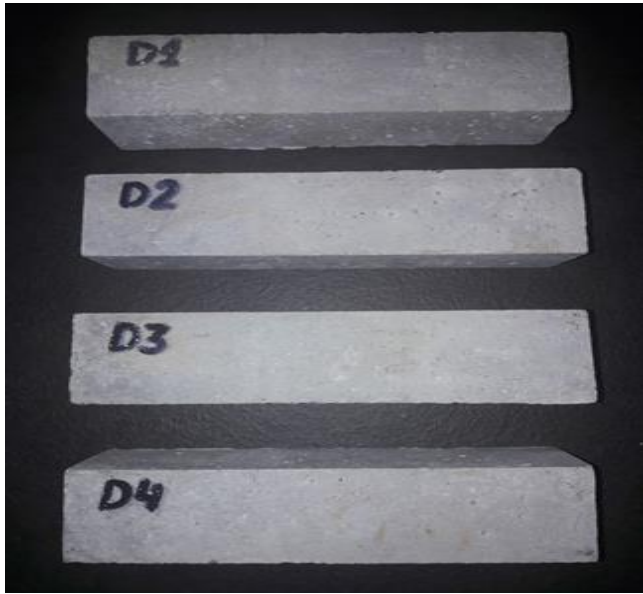
Fig. 5. Photos of specimens with granite rubble fr. 2/8 (Mix D) after 56 days in 1 M NaOH solution.

The test of Specimen D mix with granite rubble fr. 2/8 after 56 testing days gave the results presented in Figure 4. The average elongation after 14 testing days was 0.059 % and after 56 testing days the average elongation of the prisms was 0.111 %. The expansion of the prisms occurs when the specimens are cured in 1 M NaOH alkaline solution at 80 °C. The expansion is caused by the alkaline silica gel that develops in the specimen (Fig. 5). After the testing gel deposits were observed on the specimen surface evidencing alkali induced corrosion. The deposits result from the washing of alkali and silica gel or calcium hydroxide from the deeper layers of the specimen. After 56 days of testing gel deposits on the surface of the rods was the only evidence of alkali induced corrosion; no surface cracking typical of alkaline induced corrosion was observed. The test revealed that granite rubble (fr. 2/8) was not heavily contaminated with reactive rock and can be classified as Class I – very unlikely to be alkali-reactive (expansion after 14 days according to AAR-2 < 0.10 %) because no surface damage was observed in visual examination of the specimens after the test.

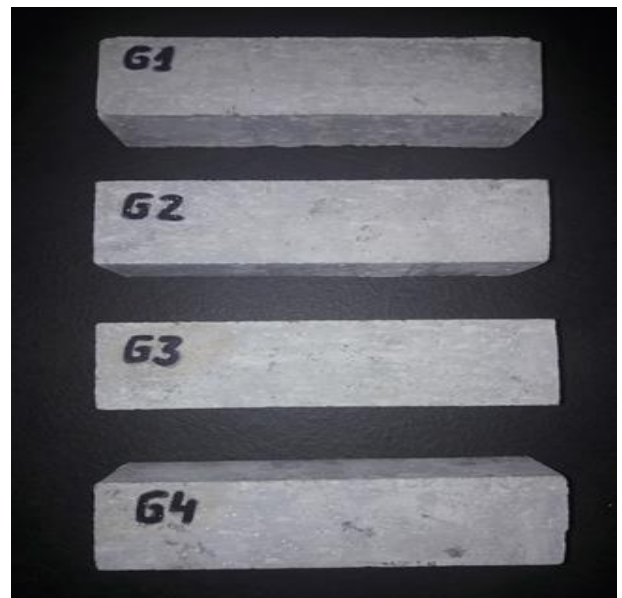
Fig. 9. Photos of specimens with granite rubble fr. 5/11 (Mix G) after 56 days soaking in 1 M NaOH solution.

The expansion of the specimens occurs when the prisms are immersed into 1M NaOH solution at 80 °C. The expansion is caused by the alkaline silica gel that develops in the specimen. Gel deposits on the surface were also observed on the specimens of Mix G; that is typical of alkali induced corrosion (Fig. 9). After 56 days of testing gel deposits on the surface of the rods was the only evidence of alkali induced corrosion; no surface cracking typical of alkaline induced corrosion was observed. Visual examination of the mortar bars did not reveal any surface damage; granite rubble (fr. 5/11) was not heavily contaminated with reactive rock that causes alkali induced corrosion and concrete degradation; therefore it can be classified as Class I – very unlikely to be alkali-reactive (expansion after 14 days according to AAR-2 < 0.10 %).

Visual examination of the mortar bars did not reveal any surface damage; granite rubble (fr. 5/11) was not heavily contaminated with reactive rock that causes alkali induced corrosion and concrete degradation; therefore it can be classified as Class I – very unlikely to be alkali-reactive (expansion after 14 days according to AAR-2 < 0.10 %).
